Report

Israel's Destruction of the Port of Gaza and
Palestinian Fishing Vessels:
October 2023 to November 2024

16 December 2024

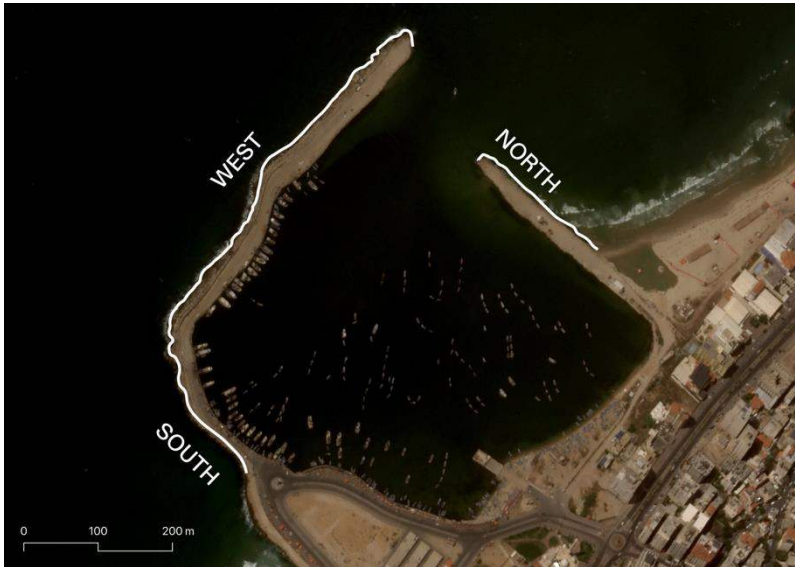
Fig 1. Layout of the port showing the north, the south and the western sections. The marking in white shows the location of the sea wall.

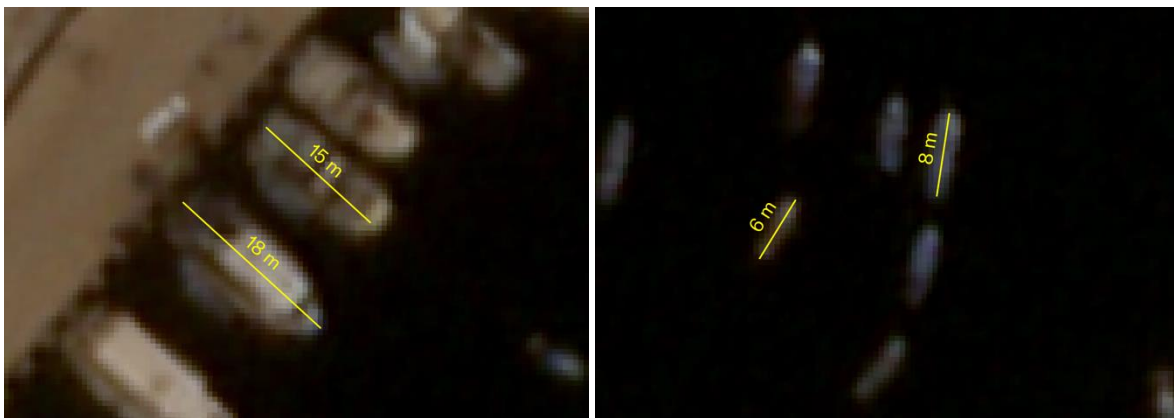
Fig 2. Samples of fishing vessels (left: 15-18m in length) and fishing boats (right: 6-10m in length) on 4 June 2023.

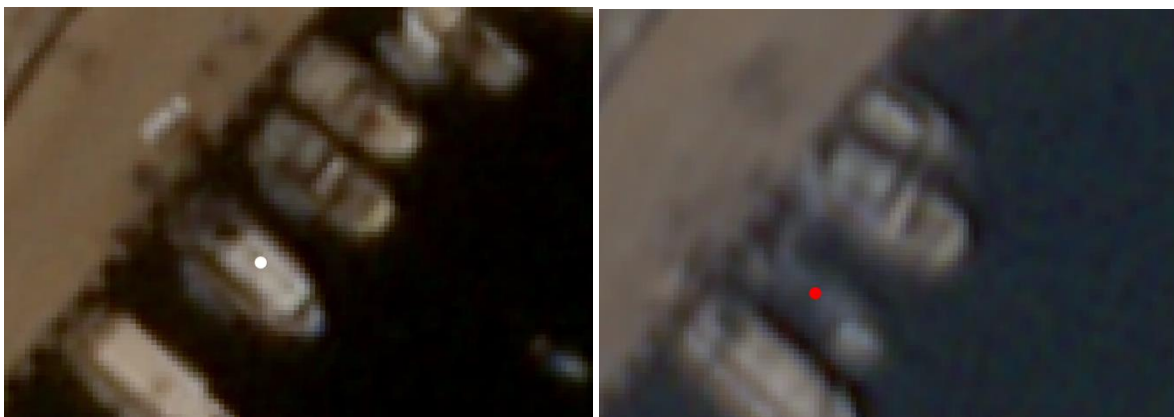
Fig 3. Comparison of satellite imagery from 4 June 2023 (left) and 14 November 2023 (right) shows that fishing vessel “No. 494” marked by a dot is damaged and partially sunken in this period.

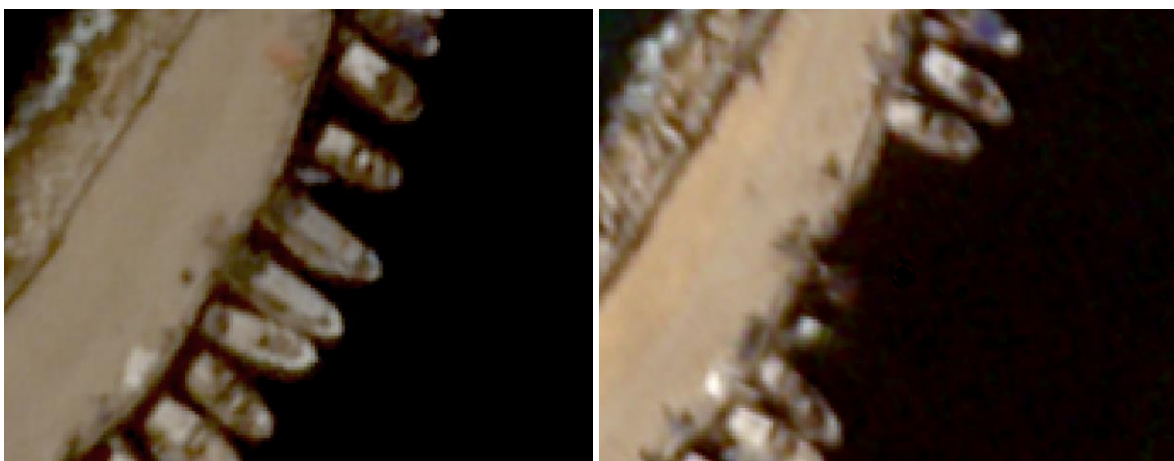
Fig 4. By comparing satellite imagery from 4 June 2023 (left) and 21 Oct 2023 (right), we identified two damaged and partially sunken fishing vessels and two disappeared in this area of the port.

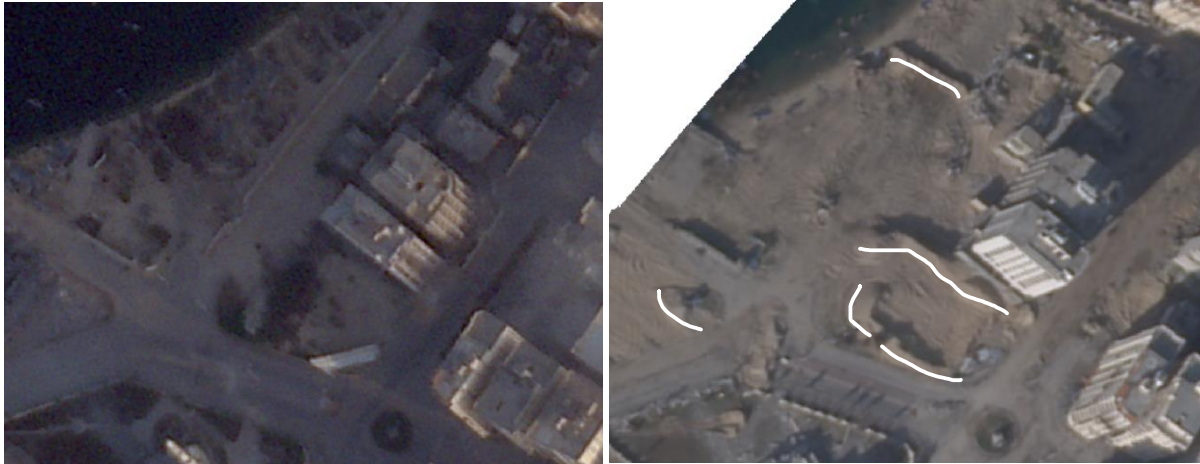
Fig 5. Comparing satellite imagery from 11 Nov 2023 (left) and 30 Nov 2023 (right) we identified earth berms and military encampments, set up by the Israeli military.

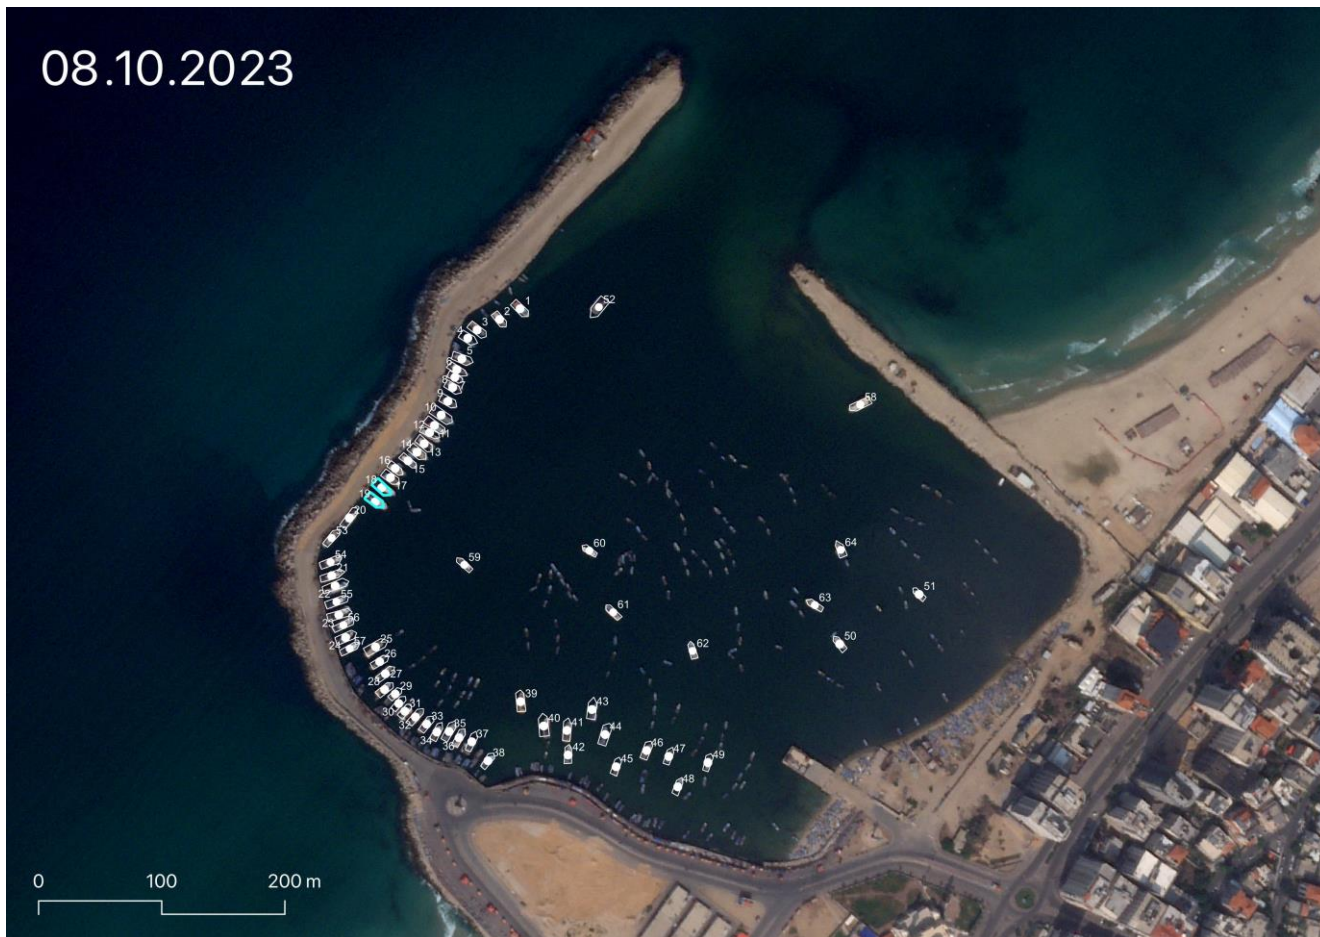
Satellite imagery from 8 October 2023 shows:

- 64 fishing vessels, with 55 vessels docked and 9 in navigation.
- Over 200 fishing boats.

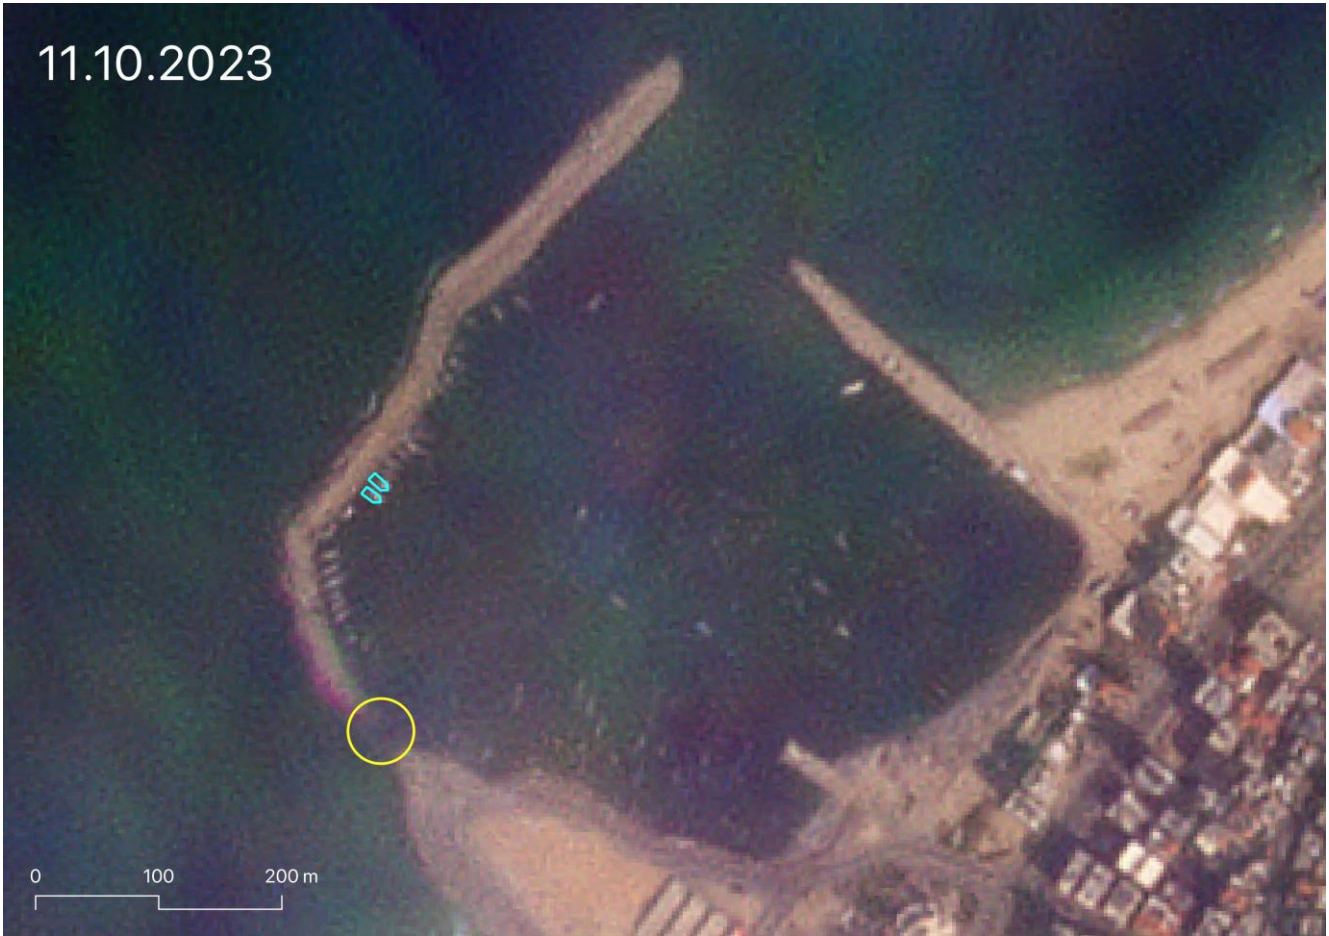
Our analysis of satellite imagery from 11 October 2023 shows the first visible damage to the port, a crater to the south of its curved sea wall.

This crater has a diameter of approximately 22m, making access from the land to the vessels and boats docked along the south and west of the curved sea wall impossible by foot. Analysis of ground-level imagery confirms that this damage is the result of an Israeli airstrike.

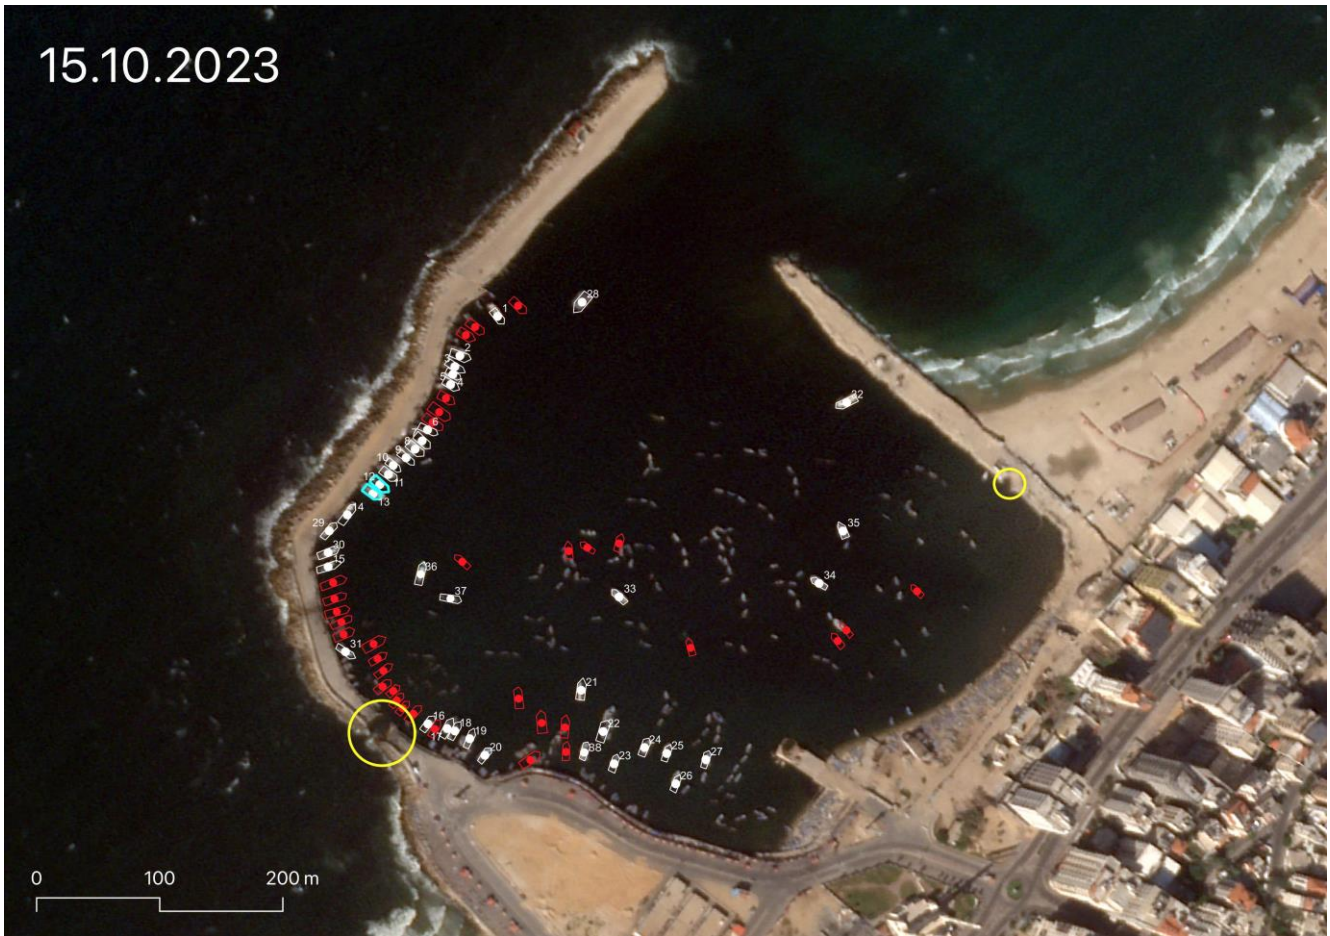
Satellite imagery from 15 October 2023 shows:

- 38 fishing vessels (marked in white) present at the port. Compared to the satellite image from 8 October, we observe that the 25 vessels previously docked have disappeared (marked in red).
- A new crater is visible on the northern part of the port (circled in yellow) evidencing that the port was subject to additional airstrikes since 8 October.

Overall, in the first week of the Israeli military campaign in Gaza, nearly half of the fishing vessels previously present in the port are no longer present, decreasing from 64 to 37 vessels between 8 and 15 October. Some vessels and boats are no longer visible in satellite imagery, suggesting that they may have left the port. For others, visible remains in the available satellite image indicate that they may have been damaged and partially sunk.

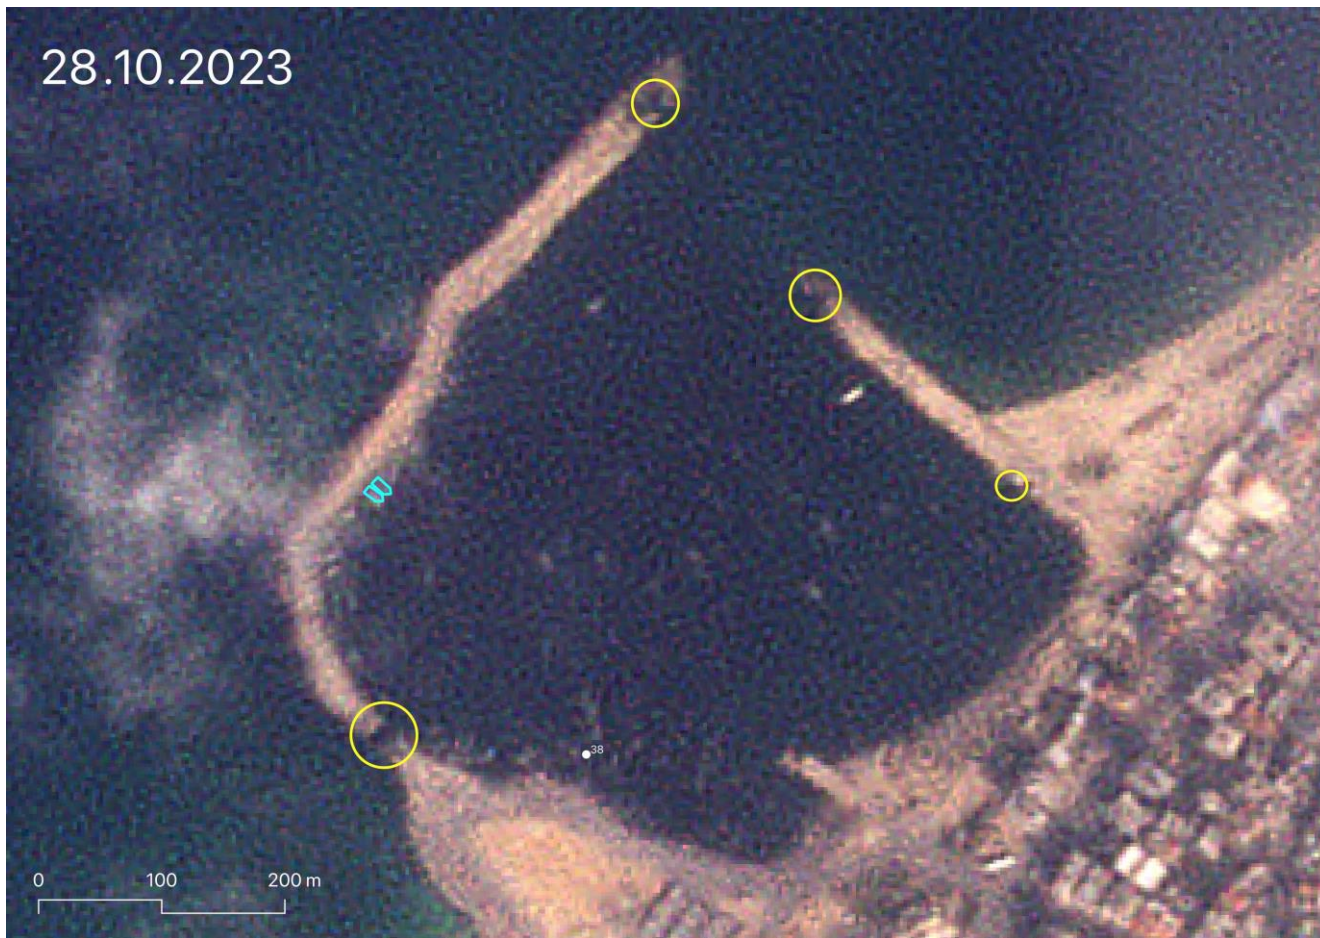
After Israel commenced its ongoing ground invasion in the north of Gaza on 27 October 2023, further damage was observed at the port.

Our analysis of satellite imagery from 28 October 2023 shows two new craters at the extremes of the north and west sea wall (marked in bolded yellow) of the port, evidencing that the port was subject to additional airstrikes since 15 October.

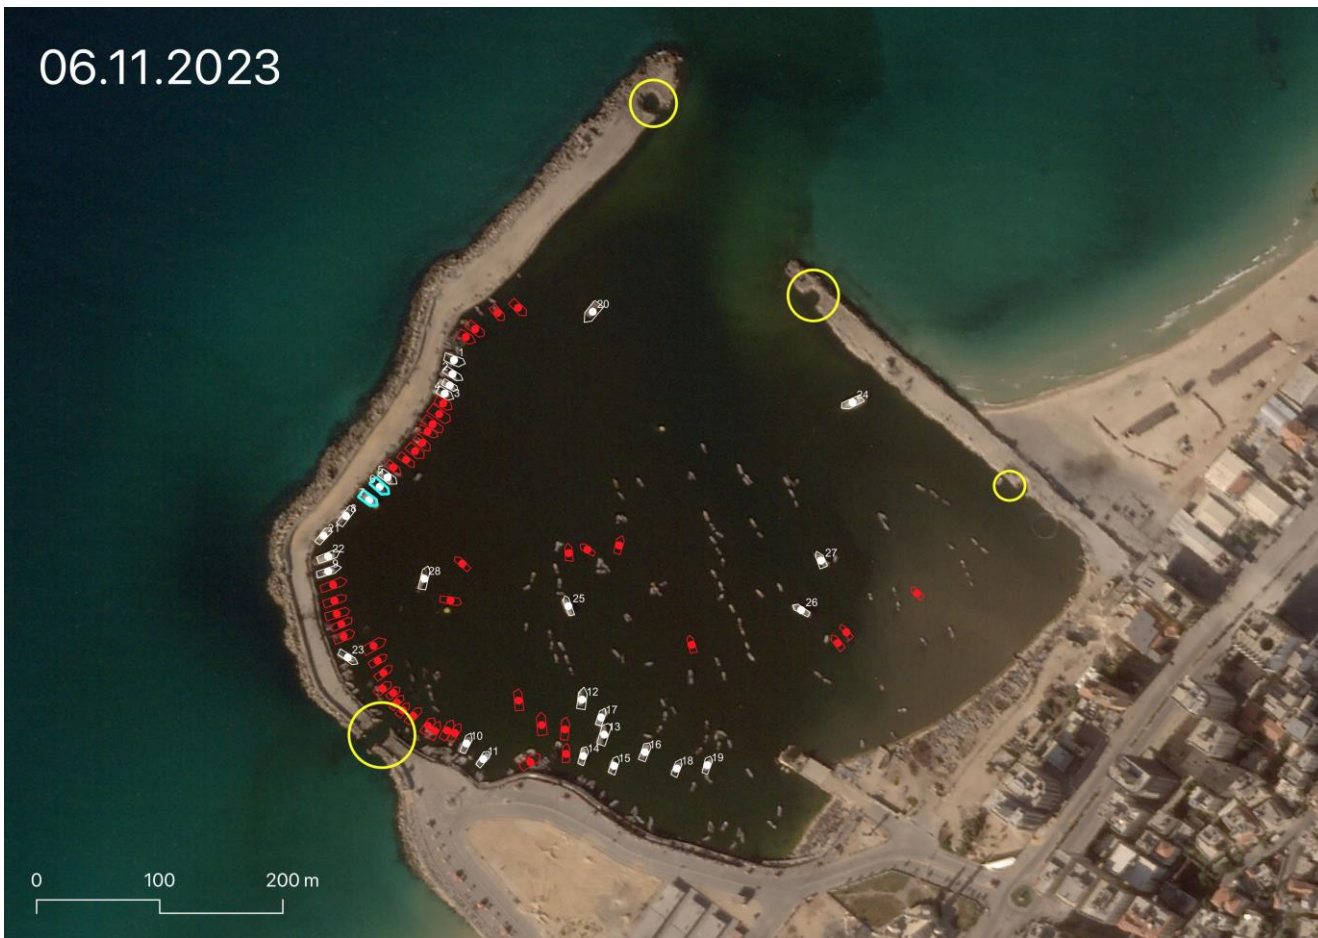
Our analysis of satellite imagery from 6 November 2023 shows 28 vessels present in the port (marked in white).

By this time, 10 of the vessels that were previously observed as docked on 15 October are now damaged, appearing partially sunk.

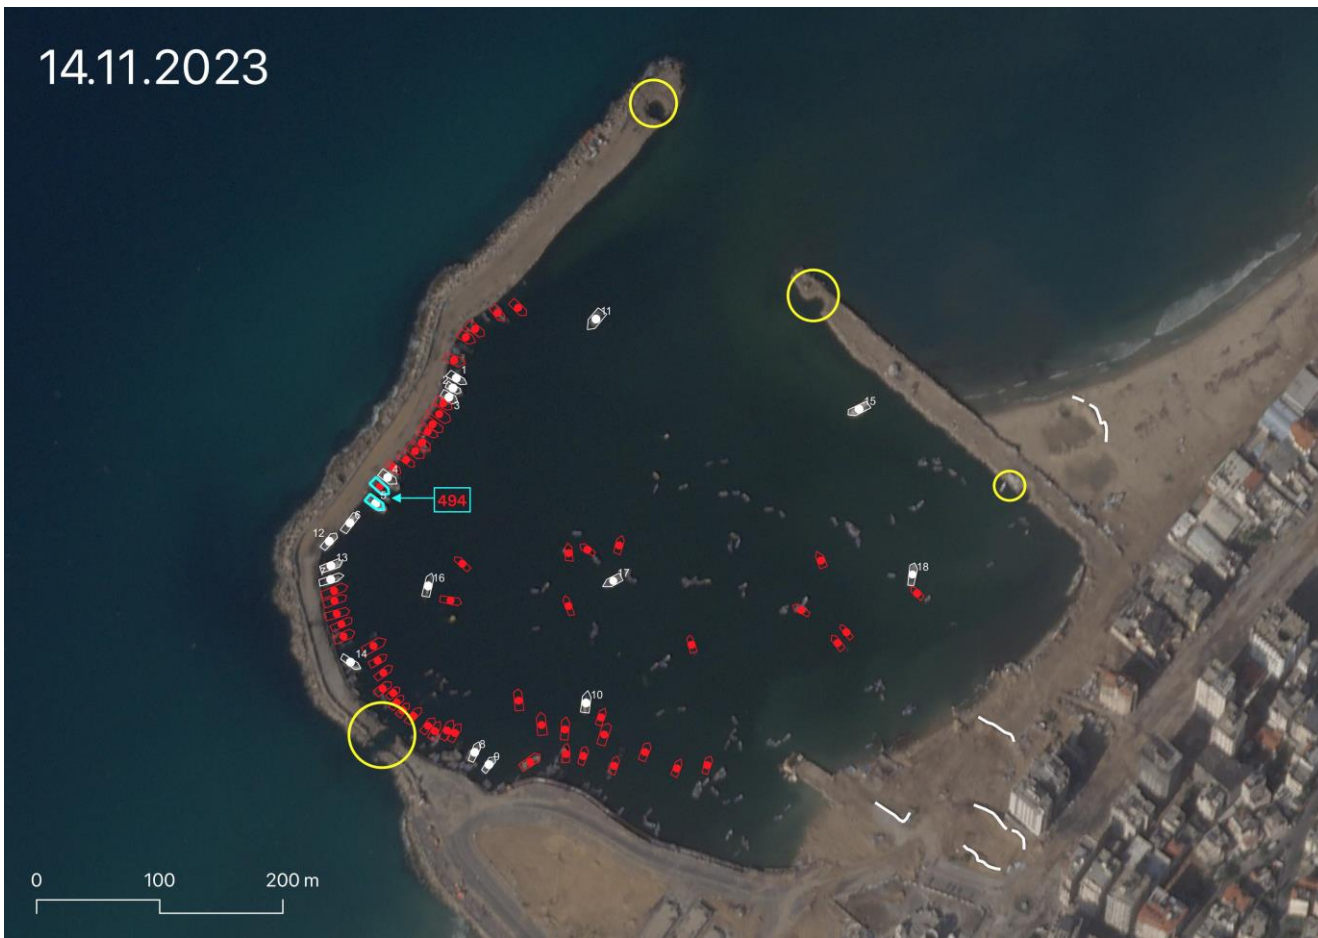
Satellite imagery from 14 November 2023 shows:

- 14 vessels present docked at the port (marked in white).
- 4 vessels navigating (marked in white).
- The first construction of Israeli military encampments and earth berms.

By 14 November, more than two weeks into the Israeli ground invasion, a total of 18 vessels are visible in the port.

In the above image, the presence of earth berms and a potential military outpost (marked in white) on the ground indicate Israeli army presence around the port at this time.

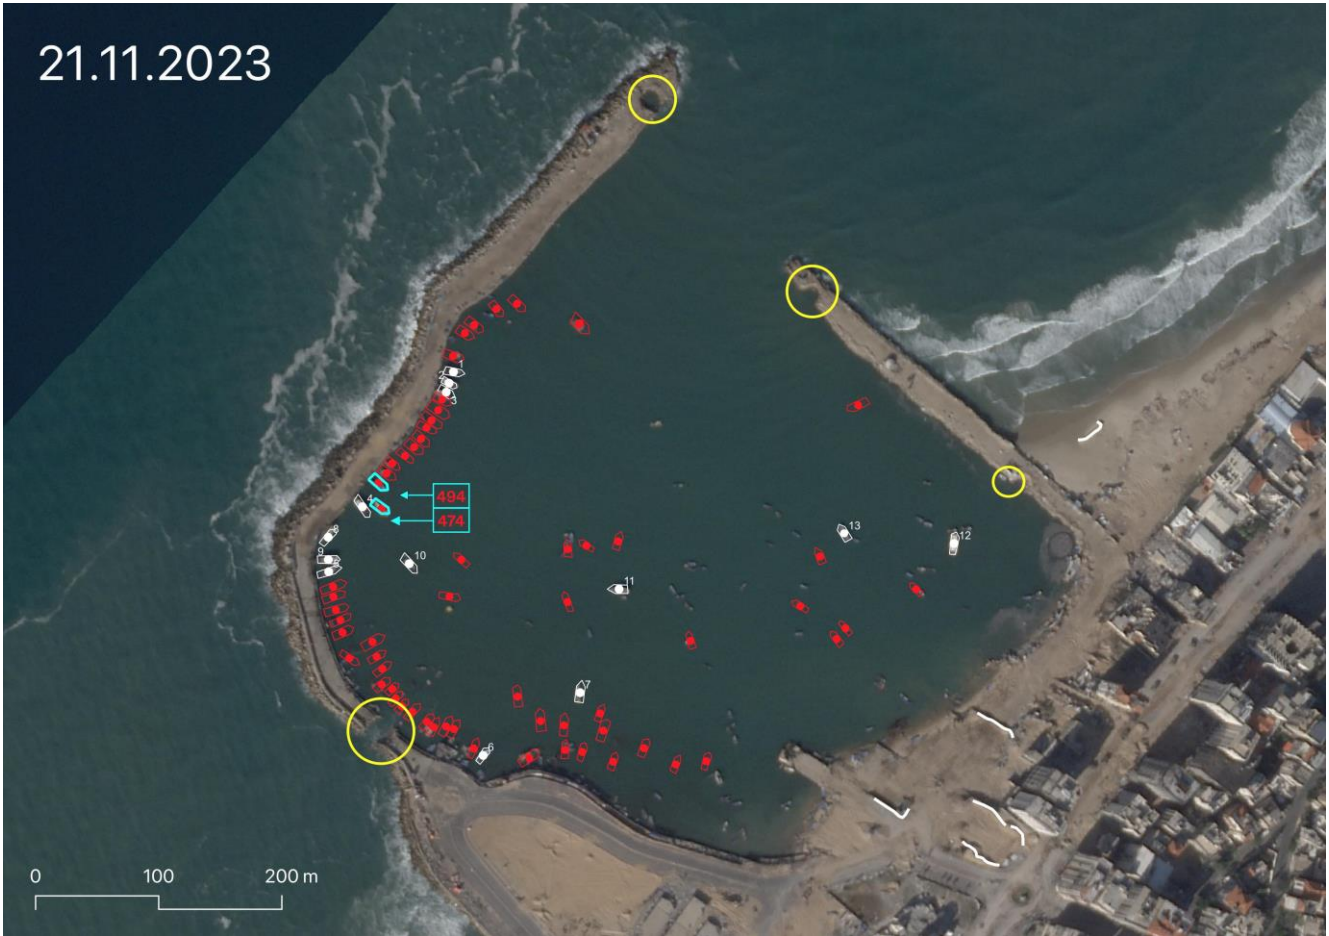
Satellite imagery from 21 November shows:

- 10 vessels present docked at the port (marked in white).
- 3 vessels navigating (marked in white).
- Israeli military encampments and earth berms.

By 21 November, a total of 13 vessels are visible in the port.

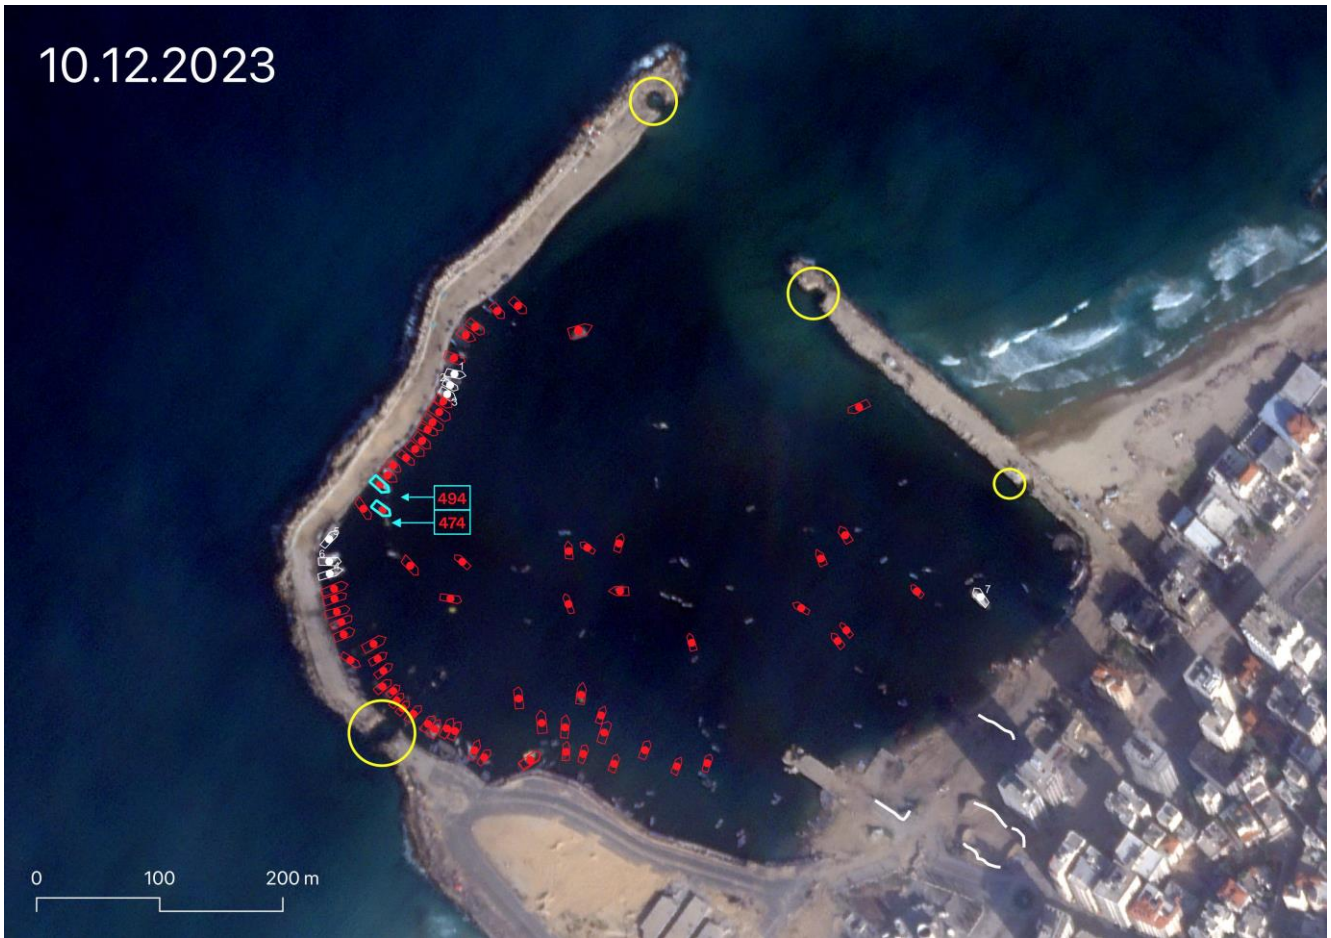
Satellite imagery from 10 December shows:

- 6 vessels present docked at the port (marked in white).
- 1 vessel navigating (marked in white).
- Israeli military encampments and earth berms.

By 10 December, only 7 vessels remain visible in the port.

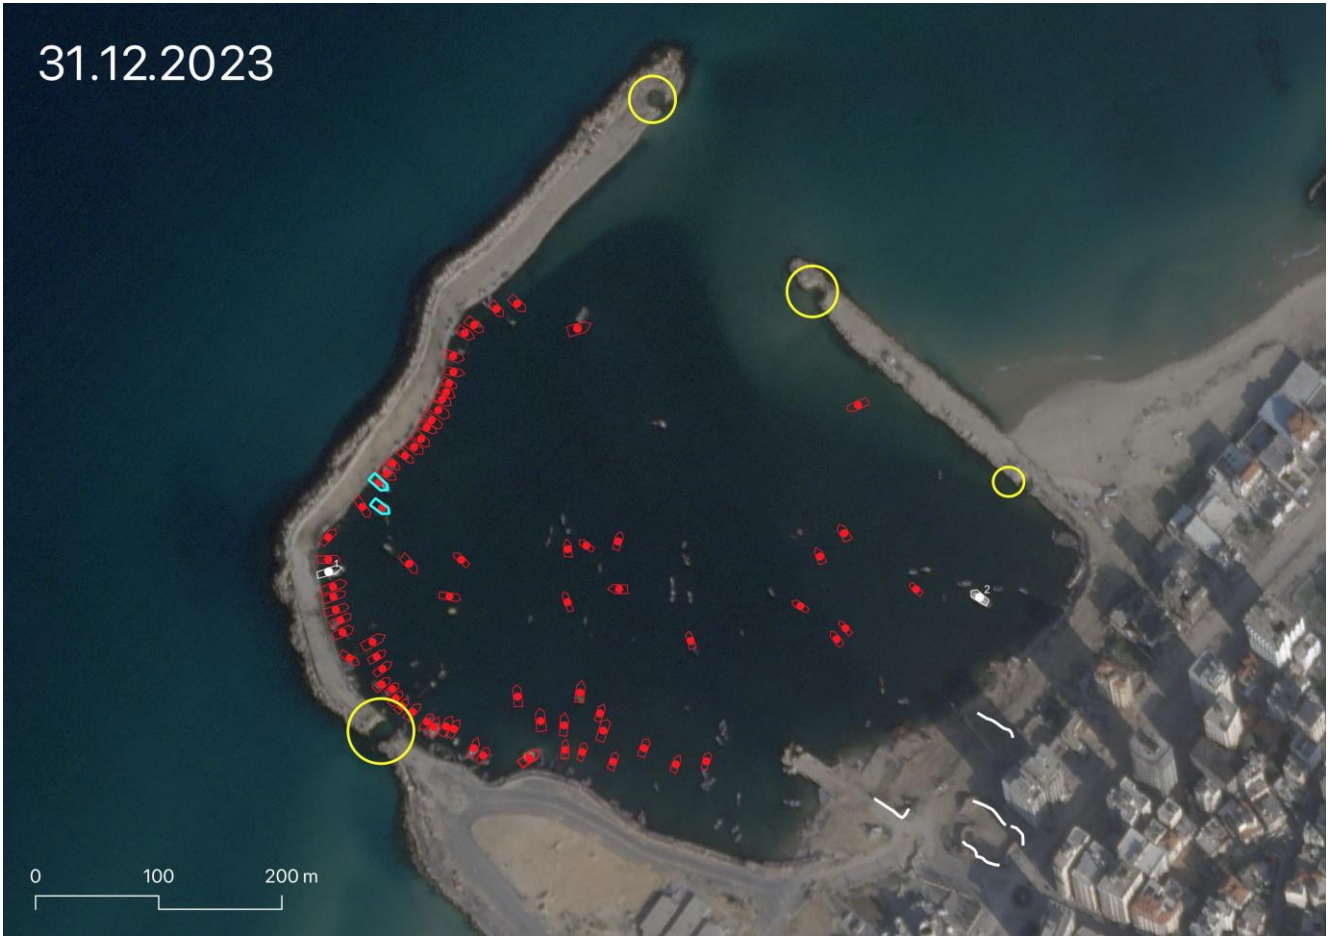
By 31 December 2023, only 1 vessel remains docked, while 1 vessel is navigating.

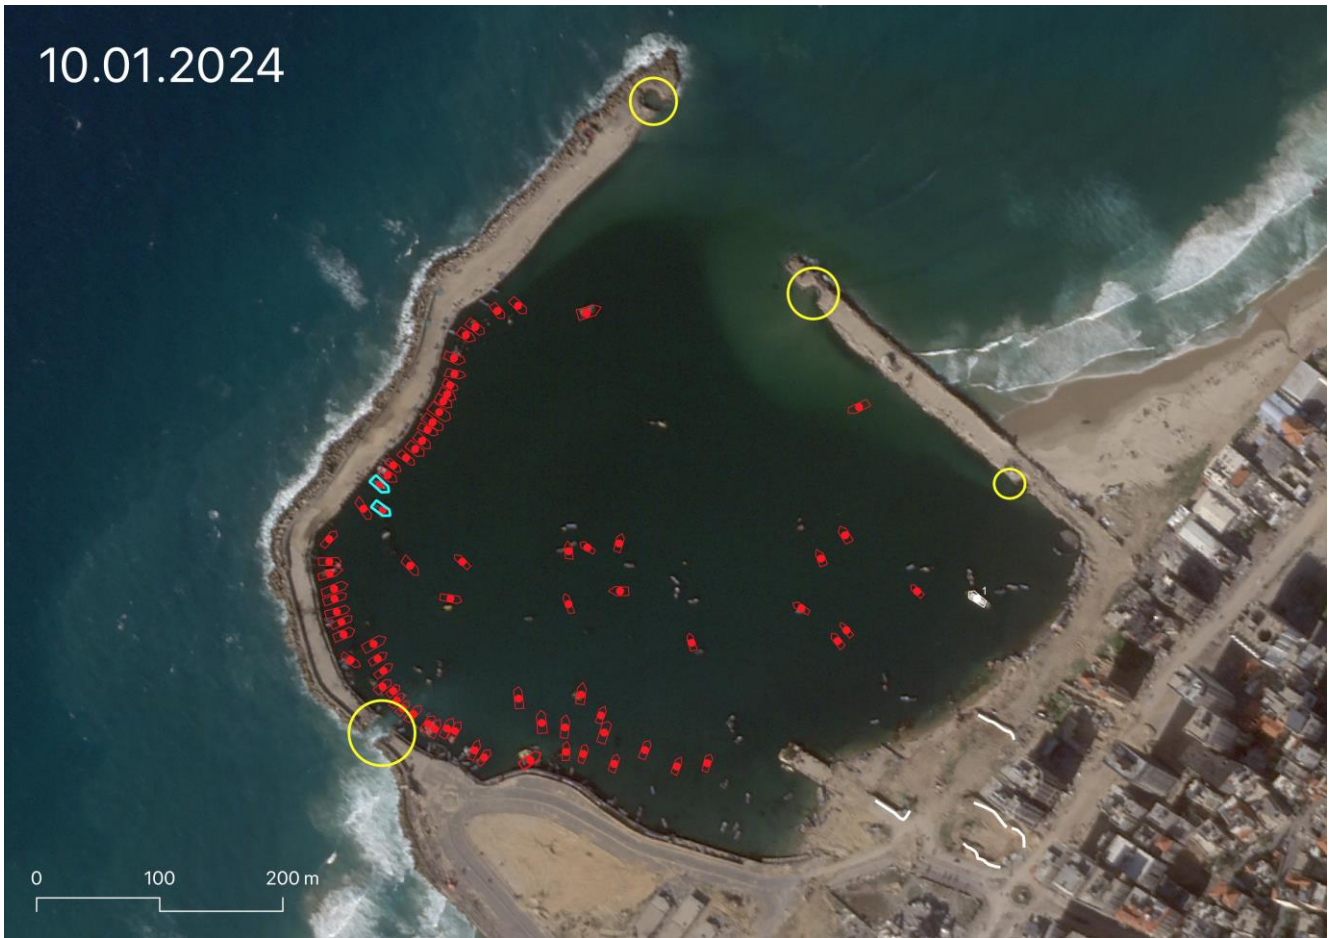
By 10 January 2024 no vessels remain docked, while 1 vessel is navigating.

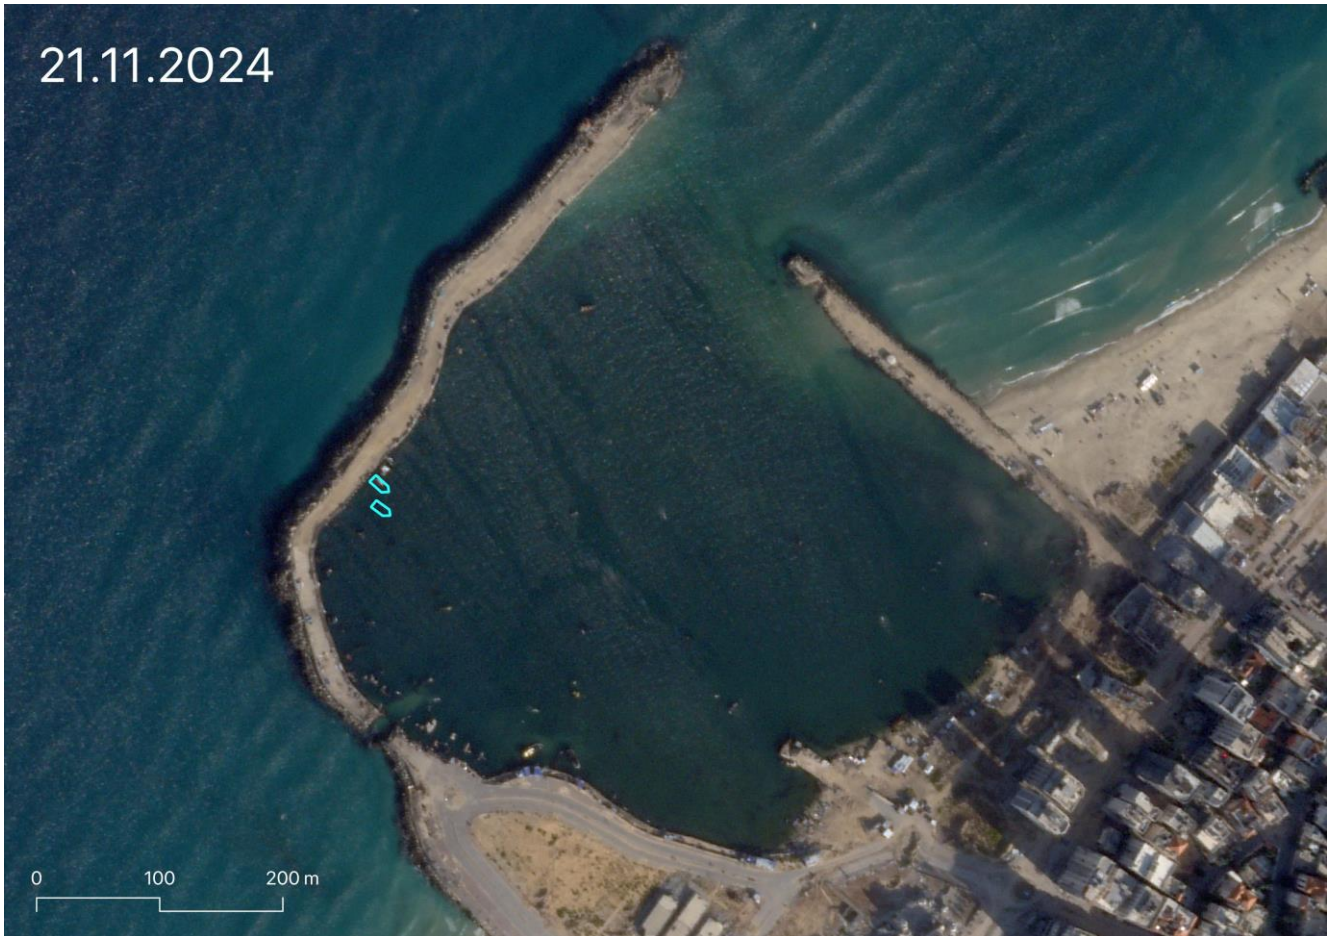
As of 21 November 2024, our analysis of satellite images shows that none of the vessels docked in the port in October 2023 are still operational. The vessels are either destroyed, disappeared or completely or partially sunk.

By this time, the Israeli military encampments and earth berms have also been removed, and tents have been erected along the beach by the port by Palestinians displaced from their homes. Analysis of ground-level imagery from 24 and 26 November confirms the same.

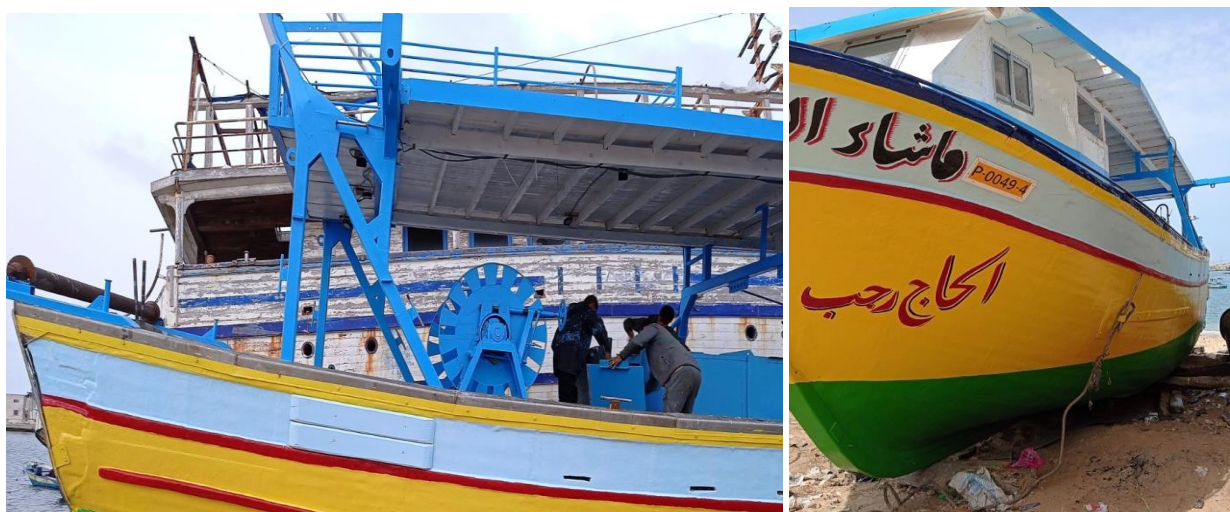
We analysed satellite imagery to determine the length of the two vessels. We measured vessel No. 494 to be 18m long and vessel No. 474 to be 19m long. Both are trawler vessels. According to a 2020 World Bank report, these vessels are typically made of wood and fiberglass and carry a trawling net.⁴

Fig 6. Images of vessel No. 494 belonging to Mr Jihad Hessi in 2022 provided to Forensic Architecture

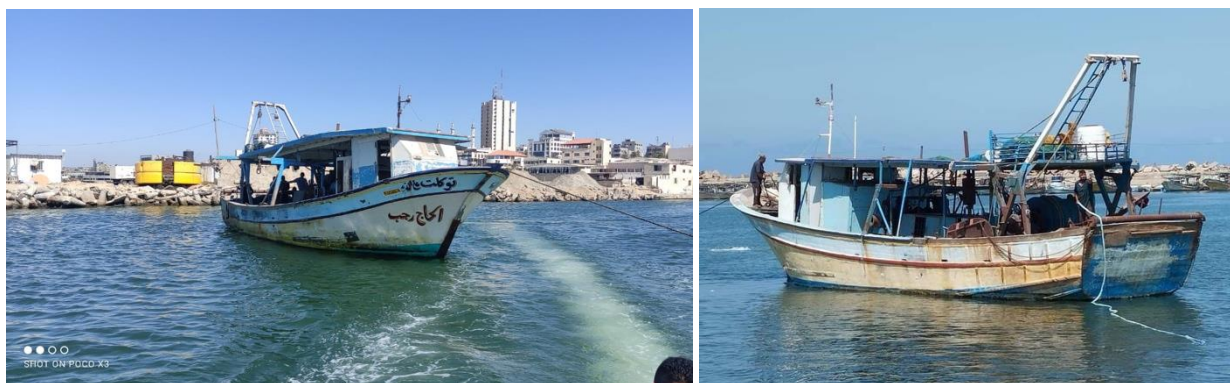
Fig 7. Images of vessel No. 474 belonging to Mr Muhammad Hessi in 2022 provided to Forensic Architecture

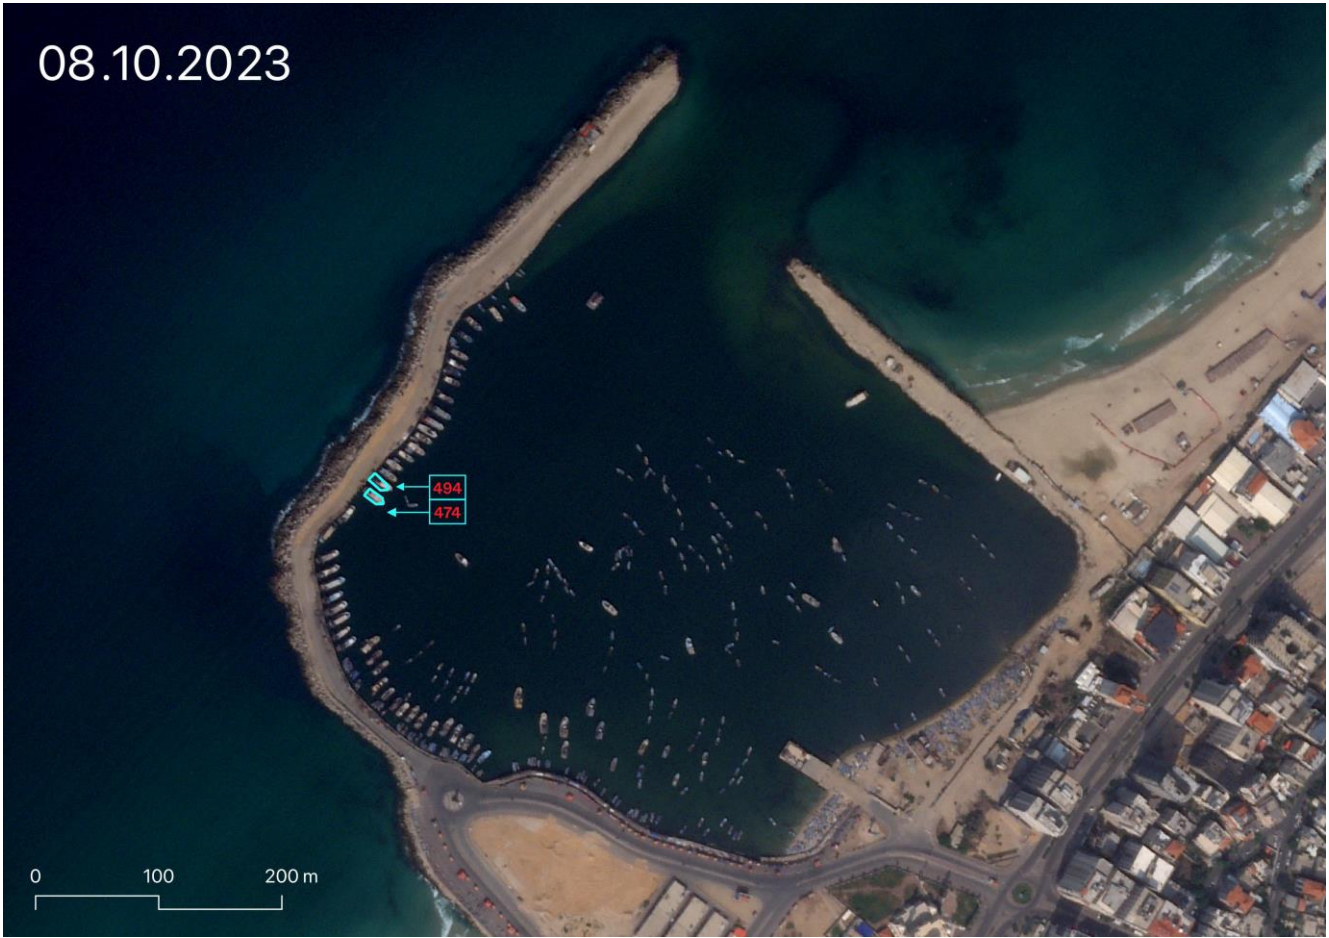
Our analysis of satellite imagery from 8 October 2023 shows vessels No. 494 and No. 474 docked along the western tail of the port's sea wall.

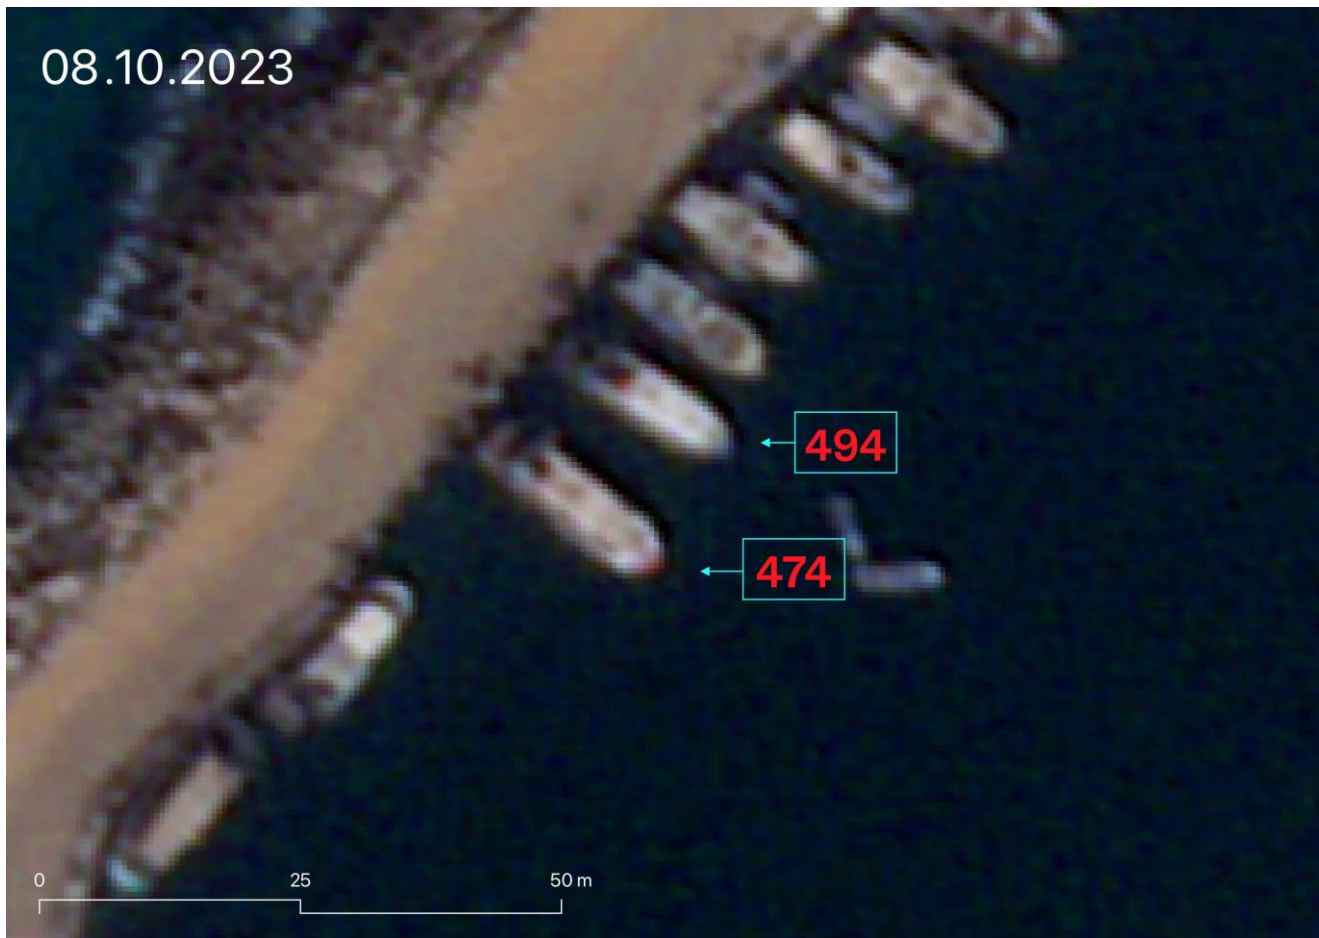
Satellite imagery from 8 October 2024 shows the vessels No. 494 and No. 474 parked in the same location after the start of the current war. Their dimensions and the position of the docked vessels is consistent with the satellite image from 4 June 2024.

Satellite imagery from 11 October 2023 shows that the two vessels remained docked in the same location, after the first airstrike on the south of the port's curved sea wall had cut off pedestrian access to the vessels.

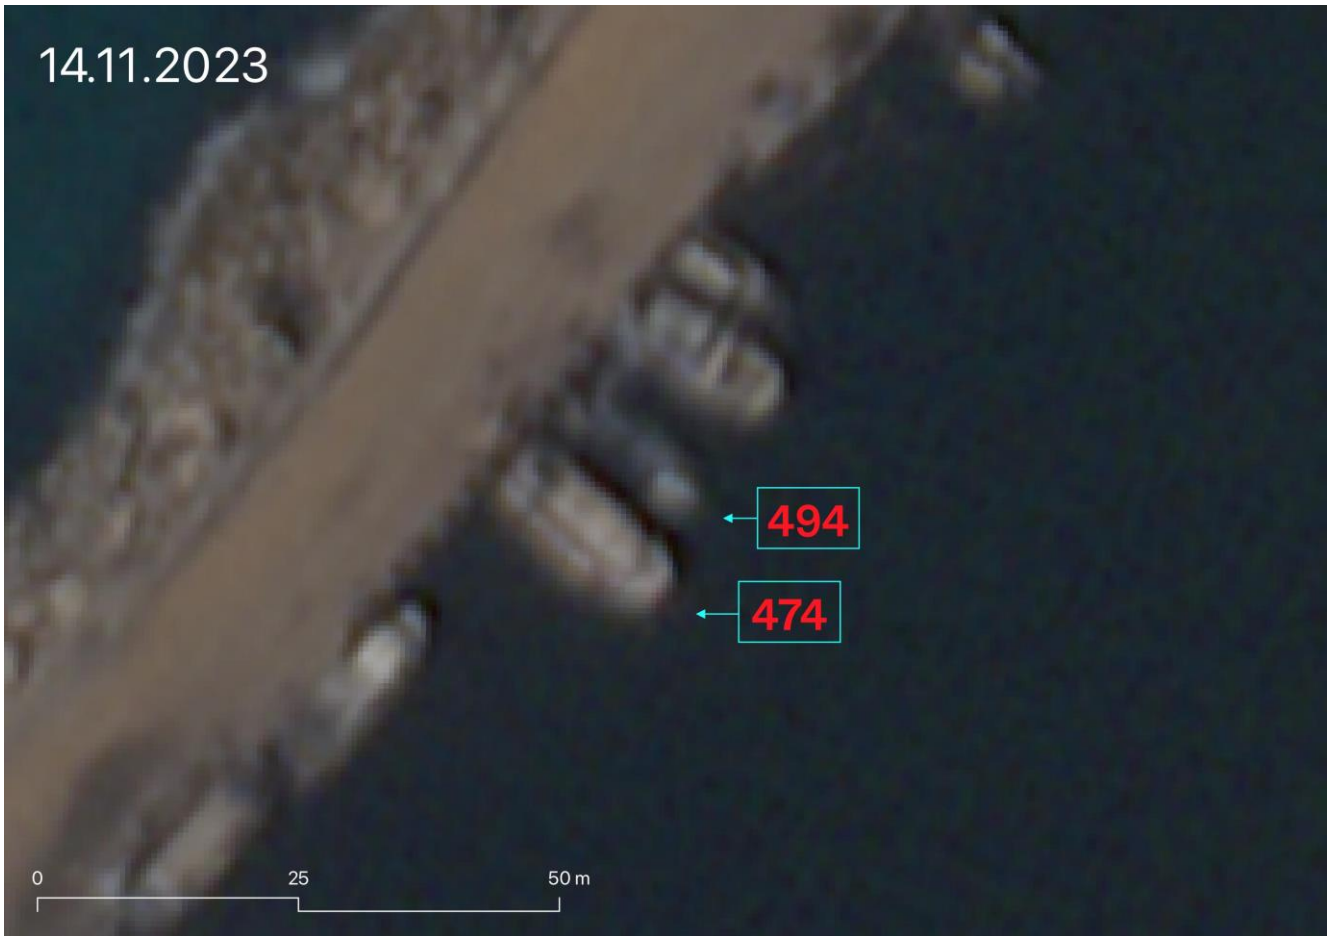
Satellite imagery from 14 November 2023 shows that both vessels remained parked in the same location by this time.

Our analysis shows by 14 November, vessel No. 494 belonging to Mr Jehad Hessi is first observed as being partially submerged and rendered non-functional.
