Report

Israel's Destruction of the Port of Gaza and
Palestinian Fishing Vessels:
October 2023 to November 2024

16 December 2024

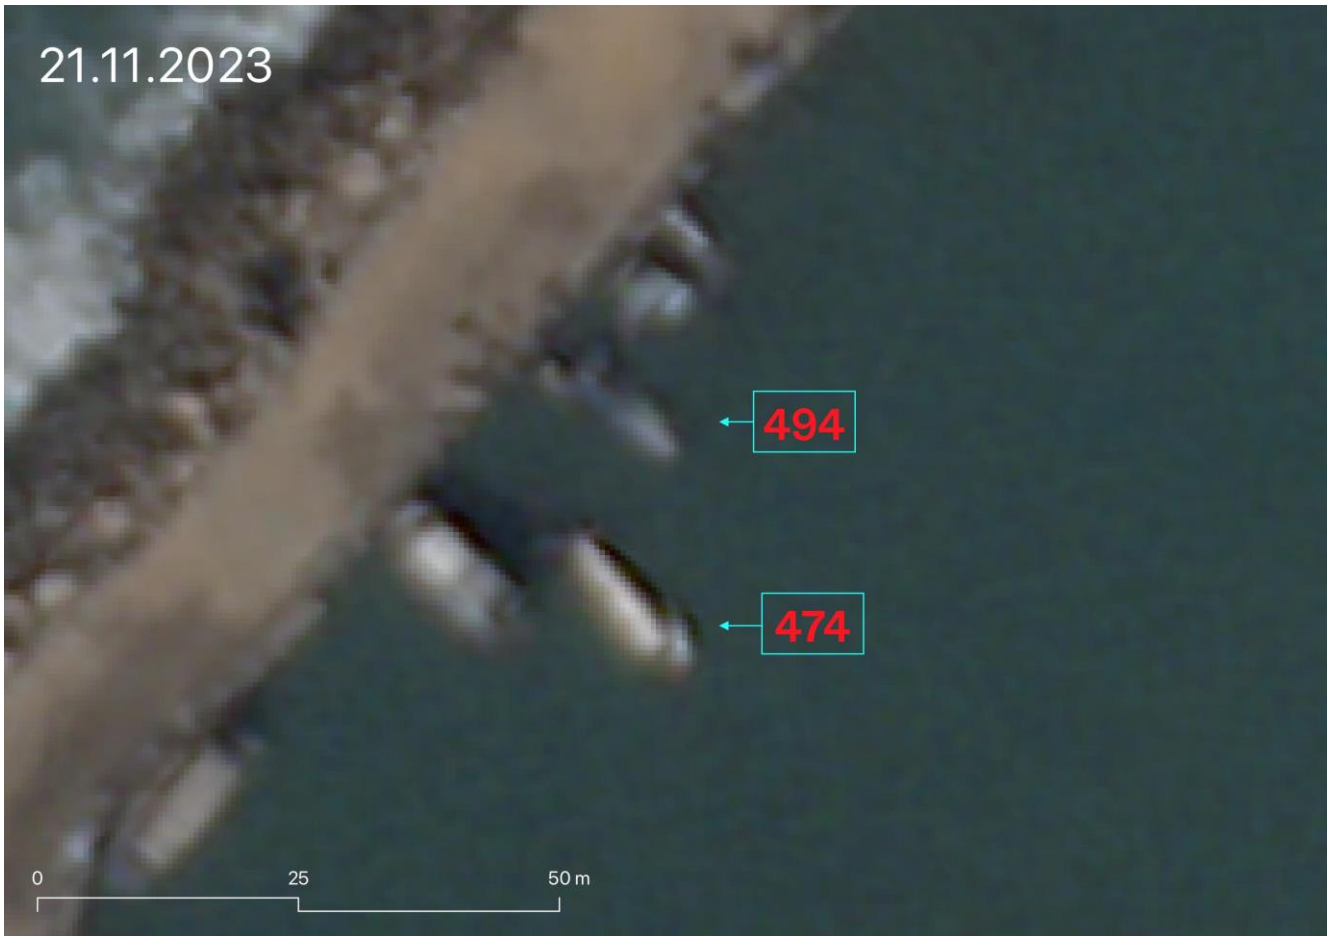
Satellite imagery from 21 November 2023 shows that vessel No. 474 owned by Mr Muhammad Hessi, is partially submerged and rendered non-functional at this time.

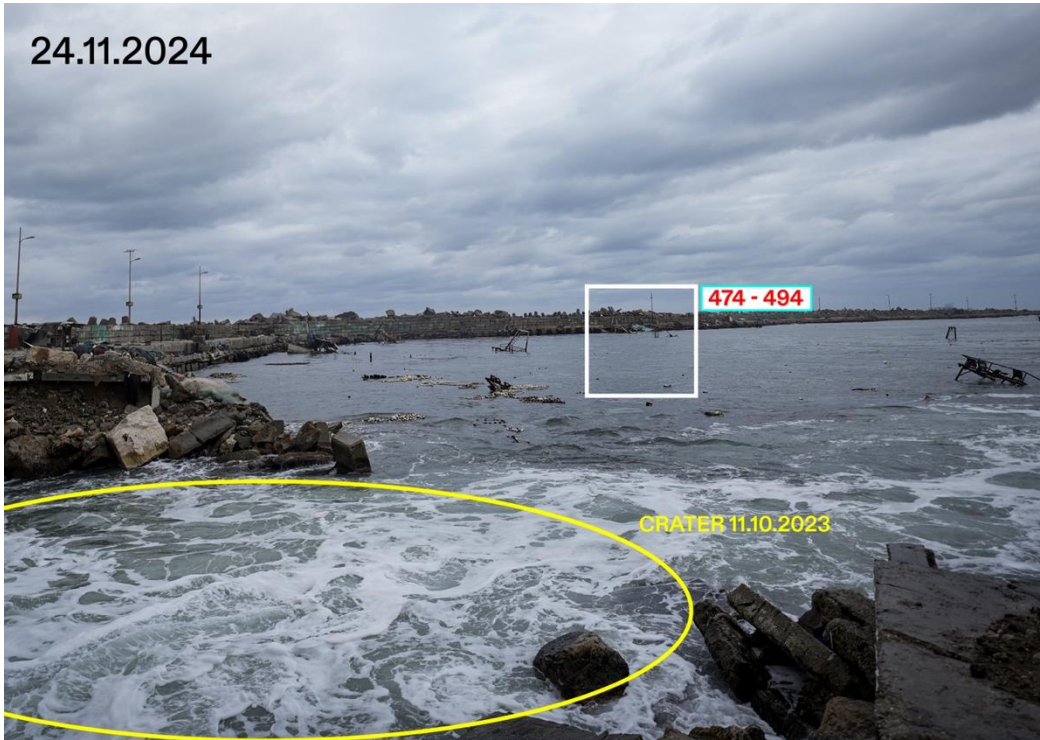
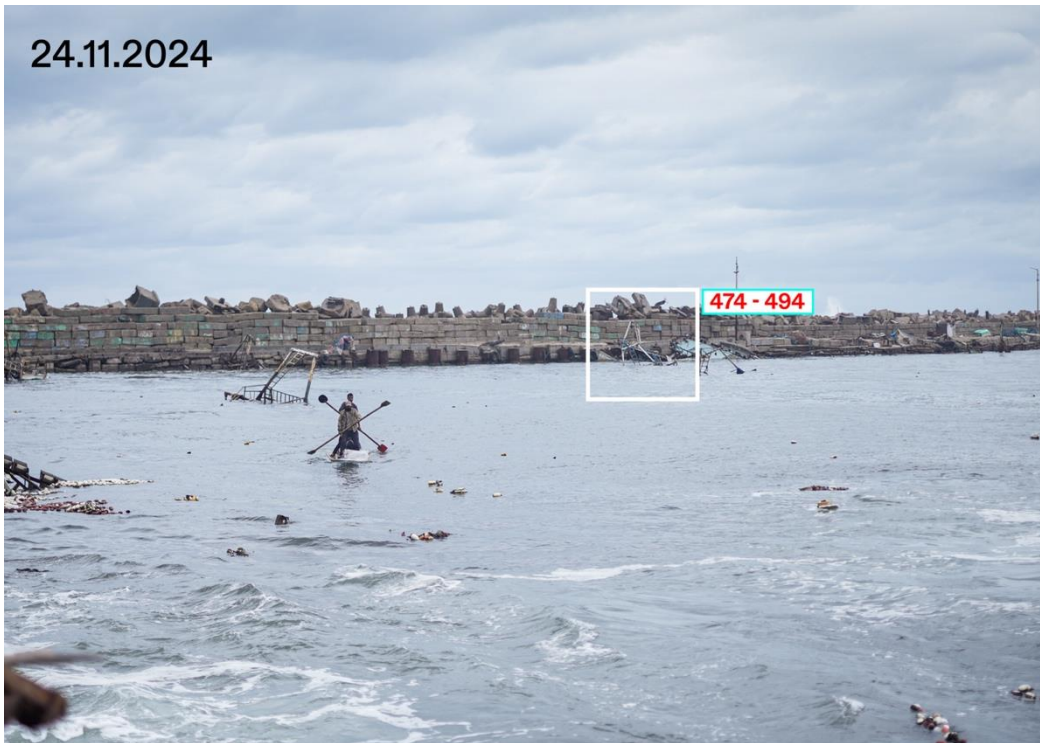
Fig 8. Image documentations of the state of the port on 24 November 2024 by Ain Media Gaza. Annotations by Forensic Architecture mark the location of the boats (in white) and the crater (in yellow).

Ground-level images collected by Ain Media on behalf of Forensic Architecture on 24 November 2024 captured the location of the remains of vessels No. 474 and No. 494.

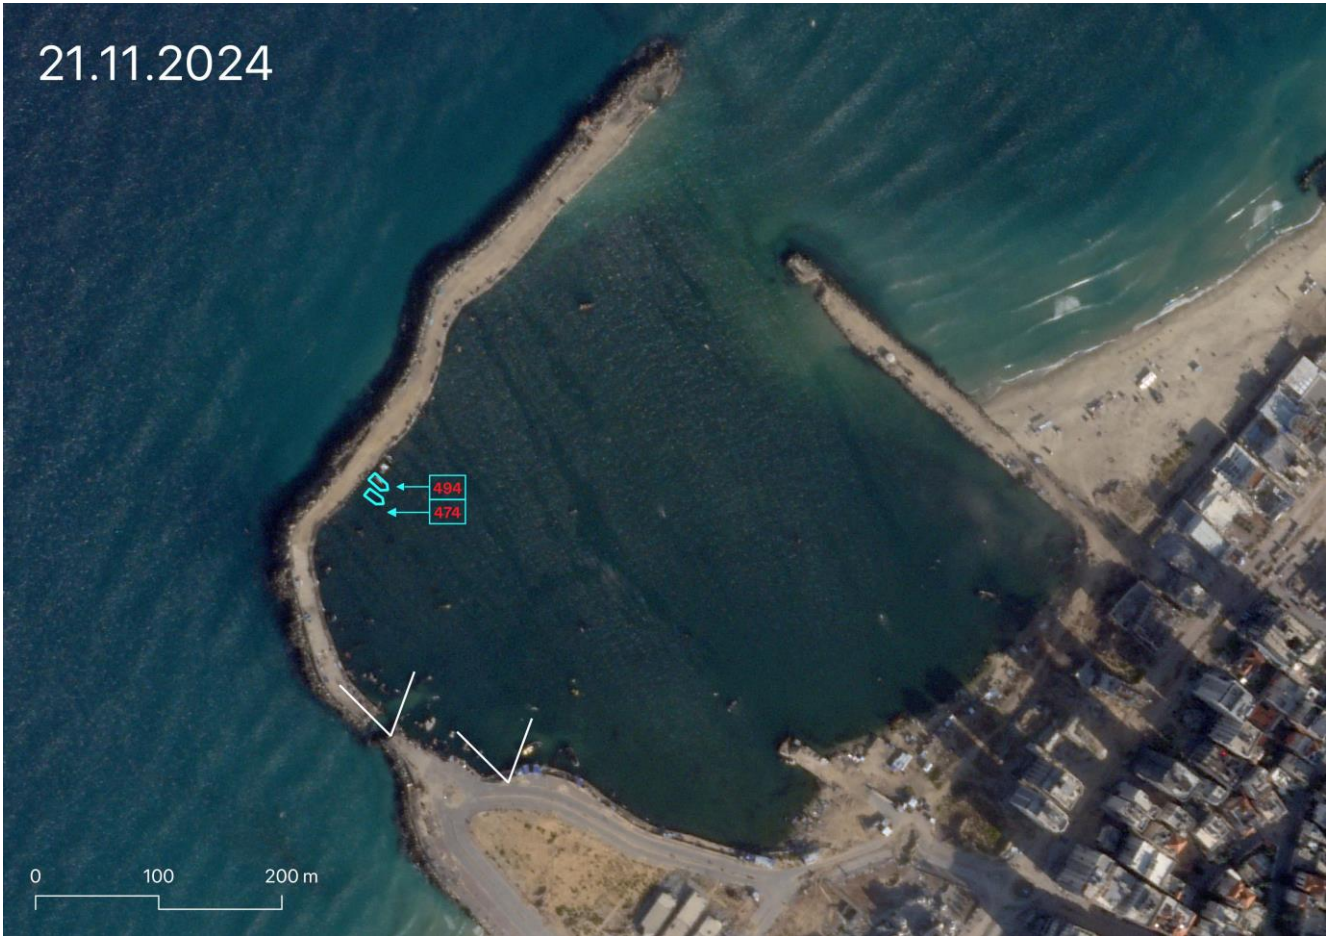
The position of the camera in relation to the boats is represented in the above satellite image with white triangles.

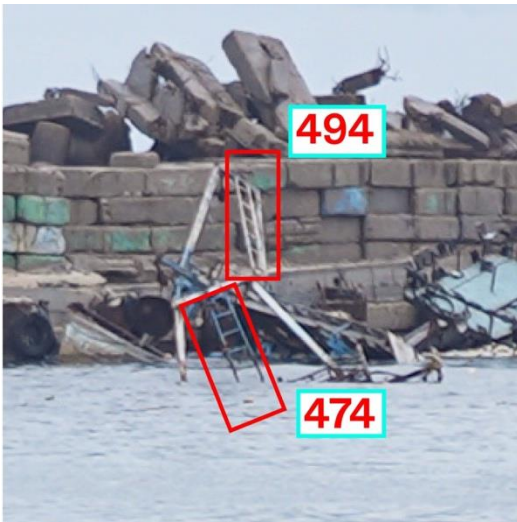
Fig 9. Image documentations of the state of the port on 24 November 2024 by Ain Media Gaza. Annotations by Forensic Architecture mark the identifying features of the boats.

We were able to identify the remains of vessels No. 474 and No. 494 by the distinctive shapes of the metal ladders attached to their respective masts.

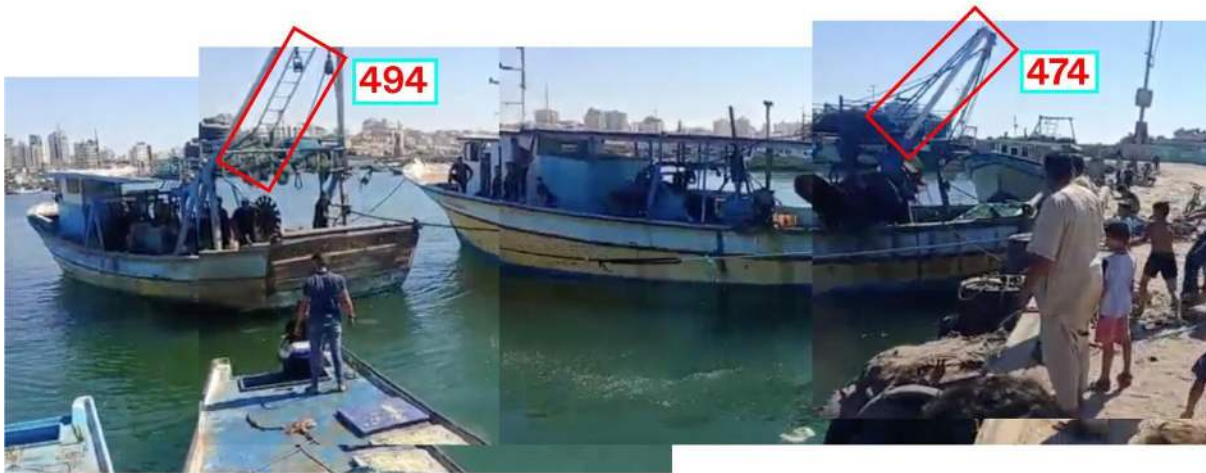
Fig 10. Image documentations of the state of the port on 24 November 2024 by Ain Media Gaza. Annotations by Forensic Architecture mark the identifying features of the boats.

Our analysis of ground-level and satellite images show that both vessels No. 474 and No. 494 are presently almost fully submerged and rendered non-functional.
