Airstrike in Barbour, Beirut

26 November 2024

Digital Incident Reconstruction
Expert Report

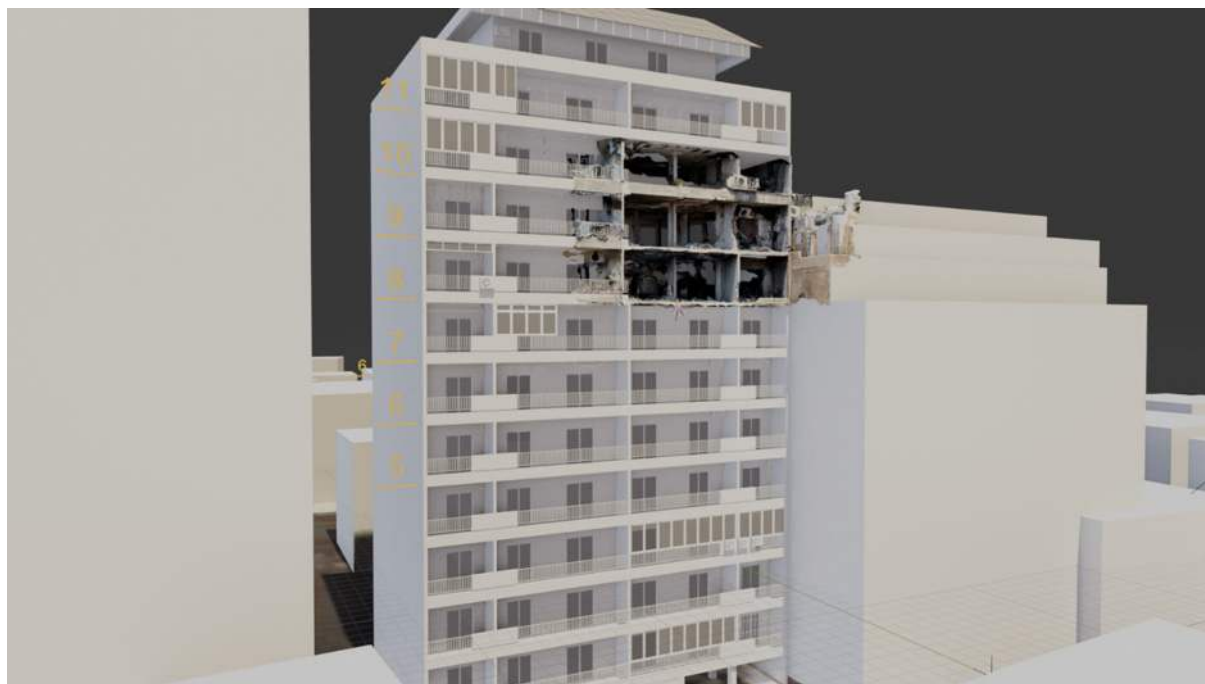
Figure 2: The site model and photogrammetry layer for the south façade of the Cherri building.

71 Image matching was also used to determine the proportions and scale of architectural objects (Figure 2). The site model was created in 3D computer-aided design (CAD) software using architectural modelling tools (Figure 3).

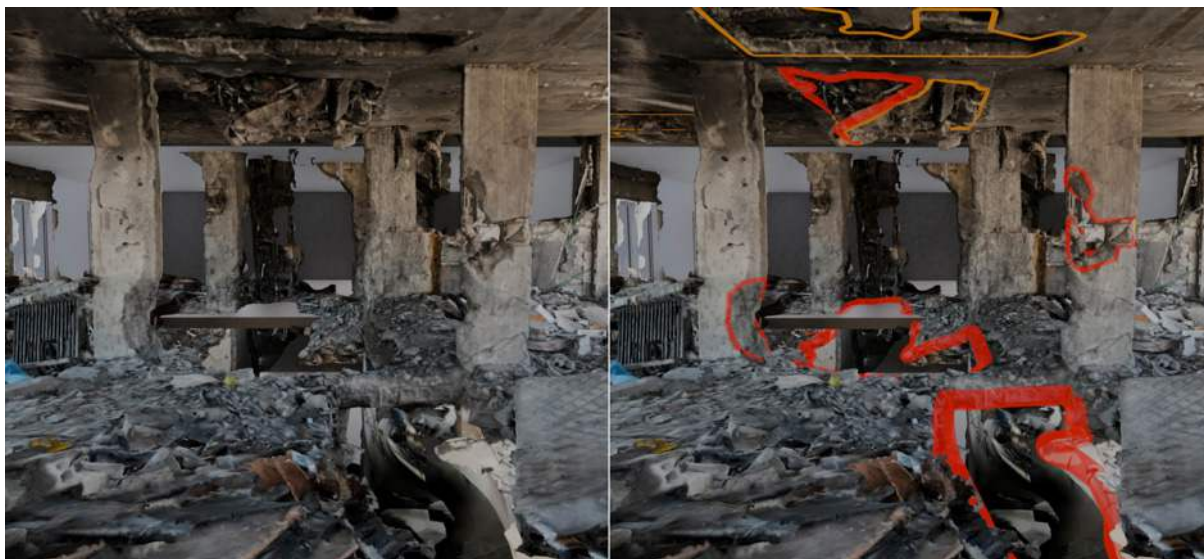
- A perforation was marked when a hole was visible through an otherwise continuous surface, such as a floor, wall, or ceiling (Figure 4).
- Surface damage was marked when damage was visible to an otherwise continuous surface, such as a floor, wall, or ceiling, but no perforation was identified (Figure 4).
- A distortion was marked where a bend or breakage was identified in an otherwise vertical structural element, such as a column (Figure 5).

Figure 4: Before (left) and after (right) annotation of perforations (red), and surface damage (orange).

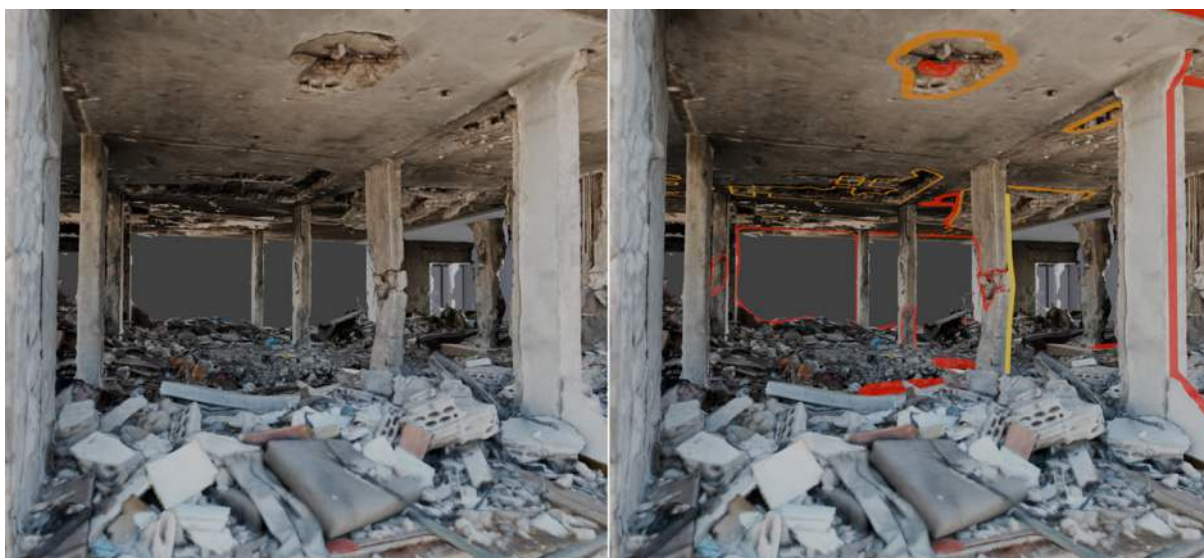
Figure 5: Before (left) and after (right) annotation of perforations (red), surface damage (orange), and distortion (yellow).

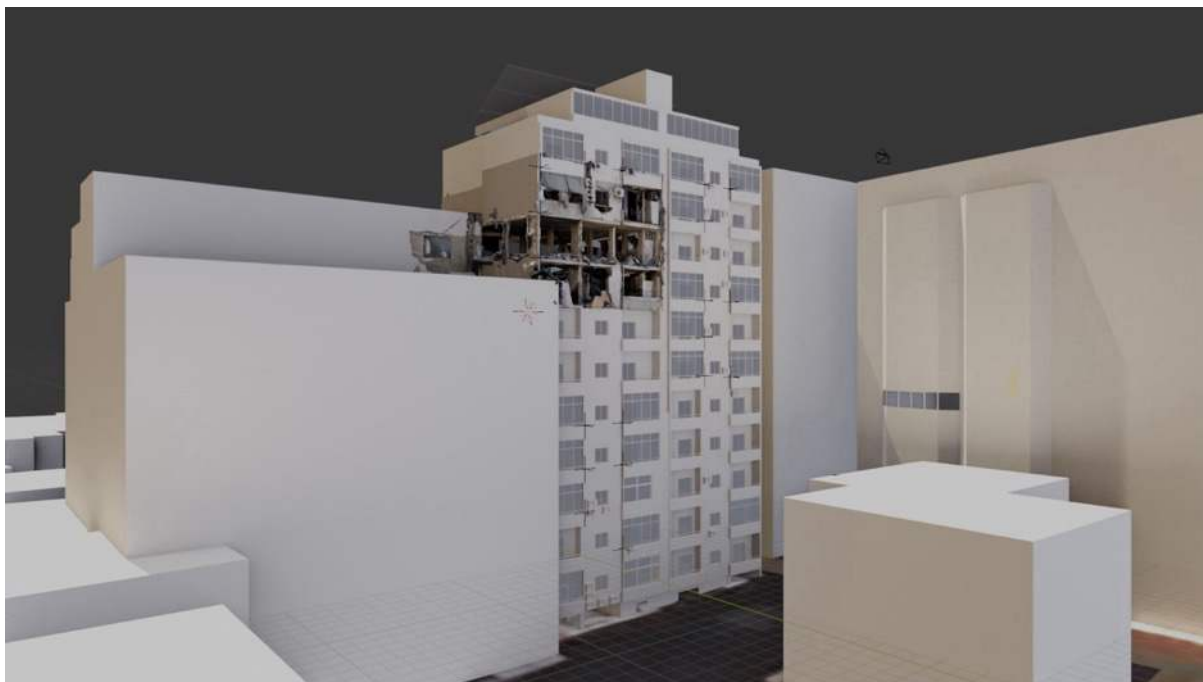
78 A second twelve-story building located to the rear of the Cherri building was also impacted by the strike (Figure 7). In this building, a missile penetrated a sixth-floor window and came to rest against an interior wall without detonating (Figure 8).

Figure 8: North façade of the Cherri building, showing the site model, photogrammetry model and the sixth-floor window of the neighbouring building (right) where a remnant was found.

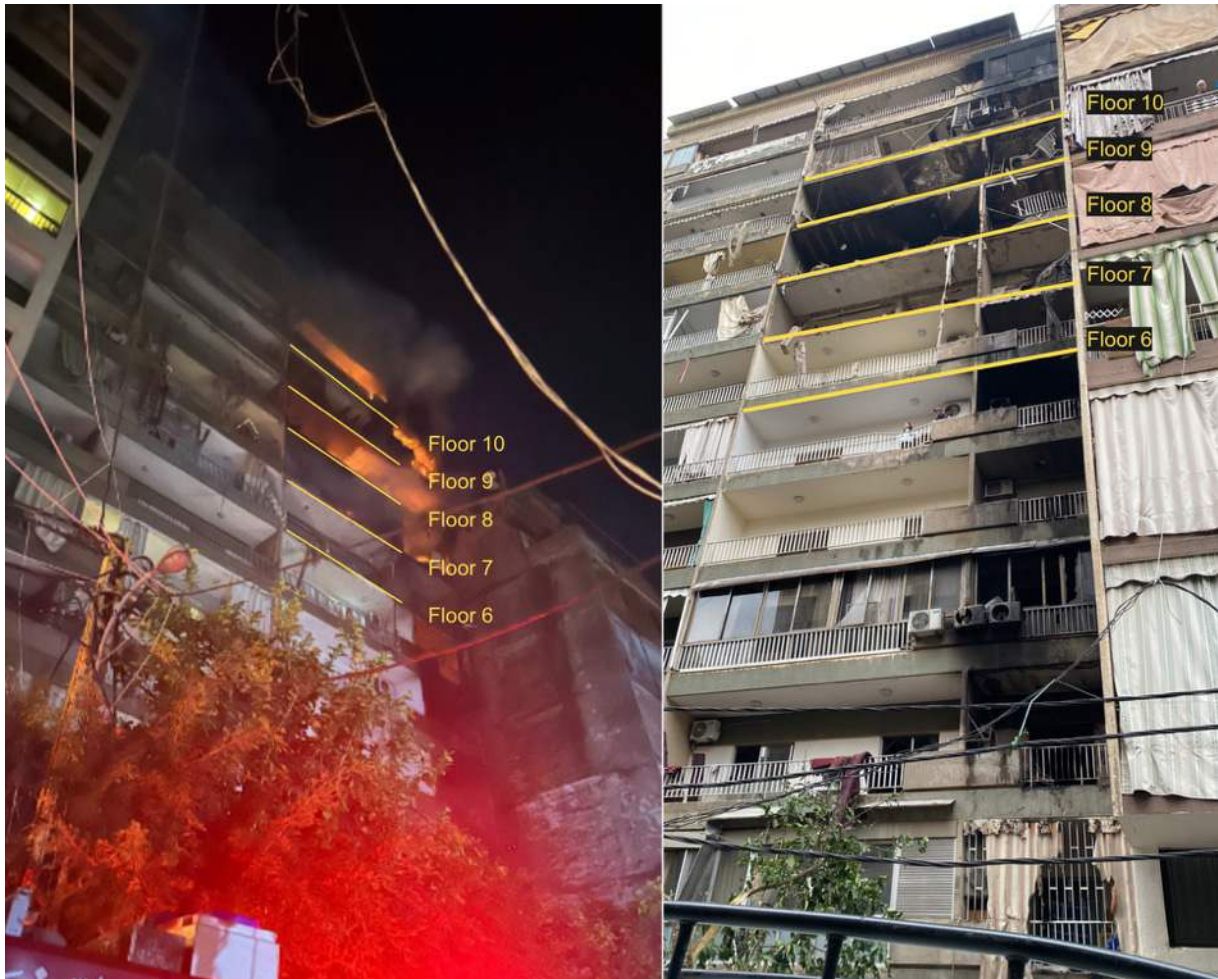
81 On the night of the incident, videos and a photograph of the southern façade show a fire burning across floors seven, eight, nine, and ten (Figure 9). A photograph from the immediate aftermath shows severe burn marks on the eastern flats.

Figure 9: Documentation from 26 November 2024 (left) and 27 November 2024 (right) showing fire and burn marks on the south side of the Cherri building.

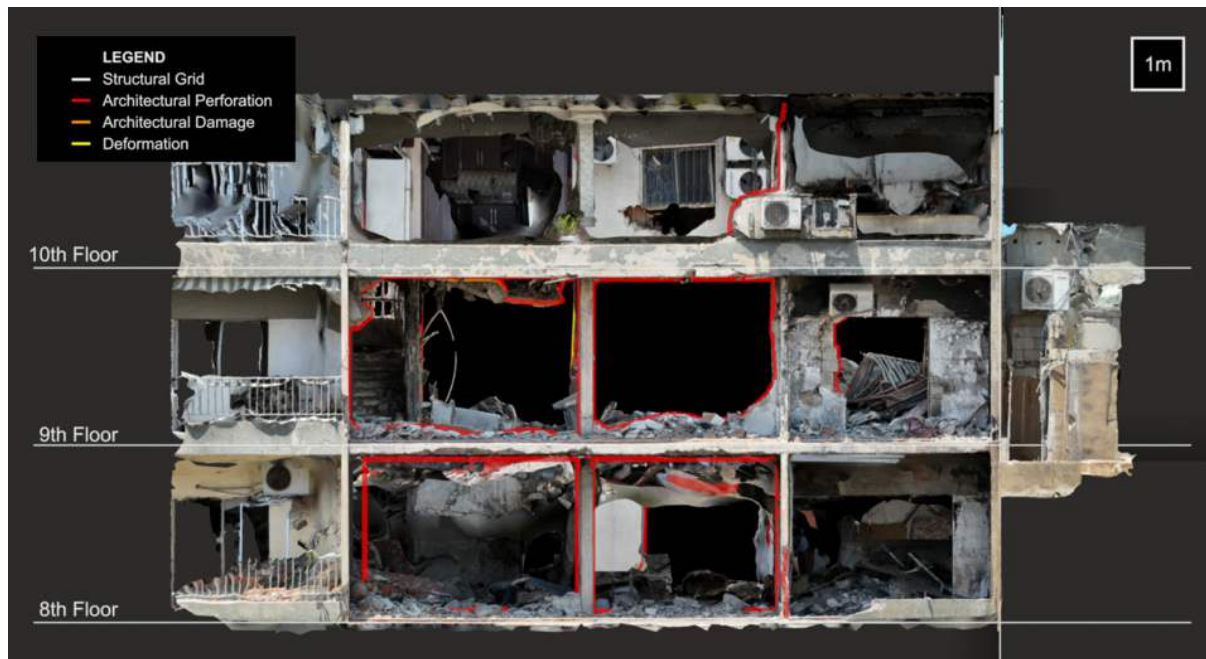
the Cherri building were destroyed, and the most severe damage was to floors seven to ten. The photogrammetry model, which maps parts of the eastern flats on floors eight, nine, and ten, corroborates the damage sustained to these floors (Figure 10).

Figure 10: Photogrammetry model showing damage sustained to the south façade of the Cherri building.

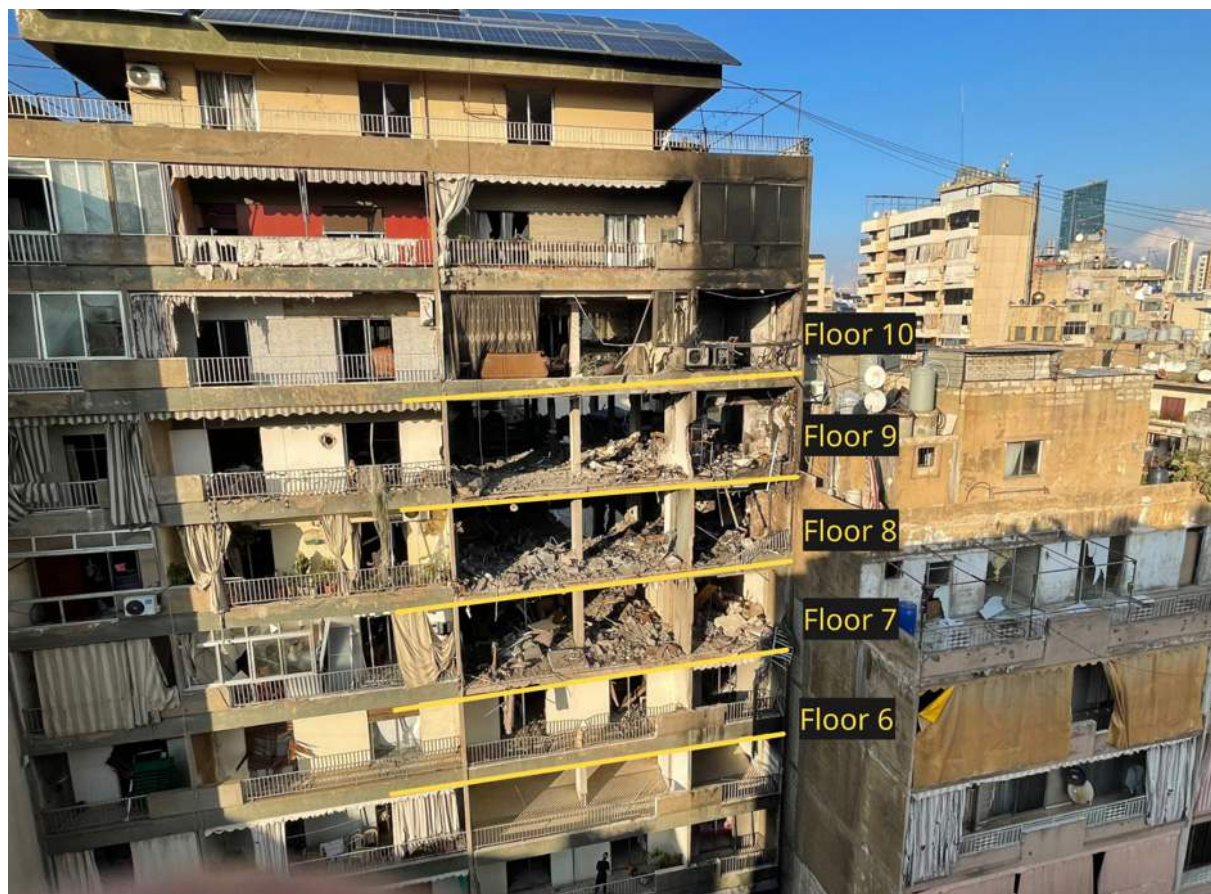
Figure 11: Photograph from 5 December 2024 showing damage to the south façade of the Cherri building.

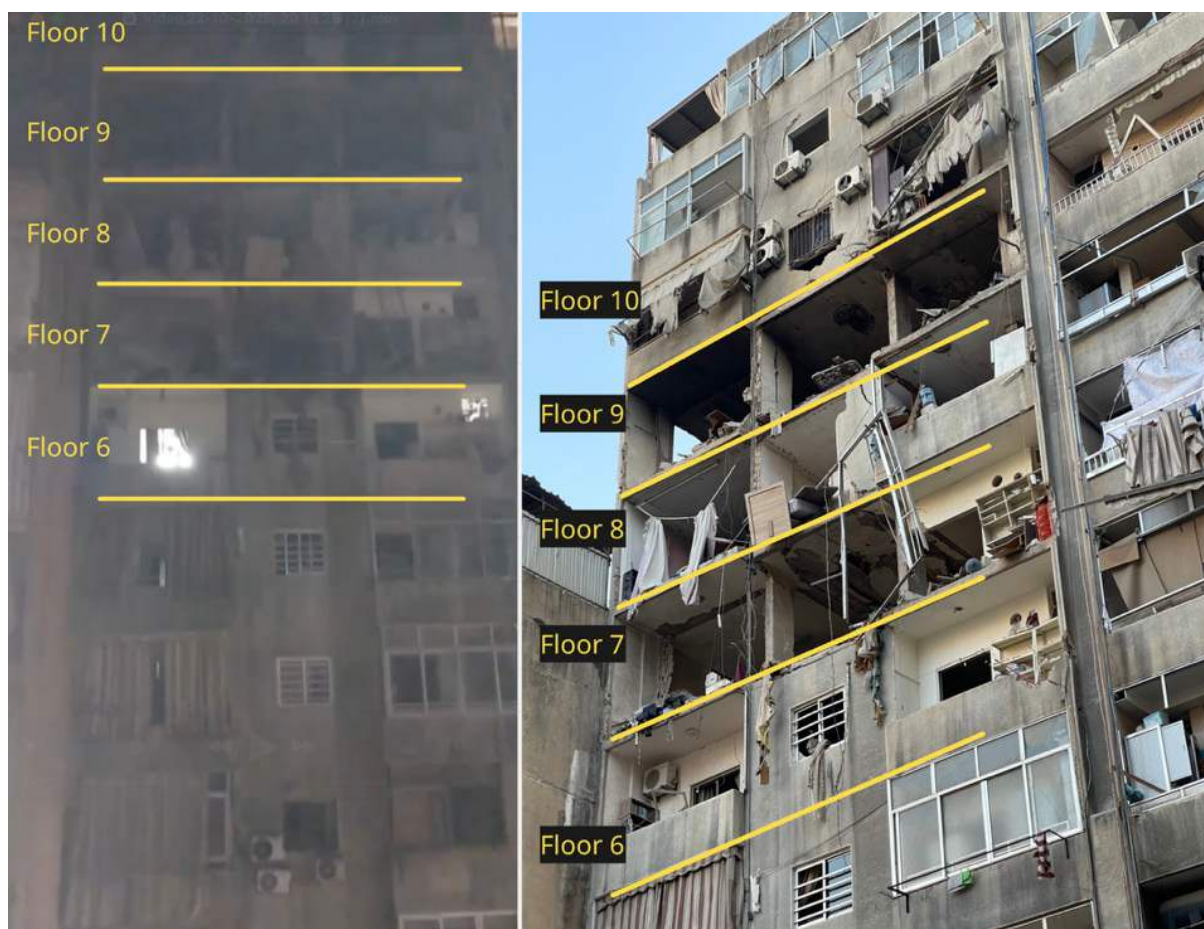
85 On the north façade, there is severe damage to floors seven, eight, and nine (Figure 12). Of the affected floors, the façade of floor nine appears most impacted: the exterior

walls are completely destroyed, and there is consistent significant damage to the rooms behind the exterior walls.

Figure 12: Photographs from 26 November (left) and 5 December (right) show damage sustained to the north façade of the Cherri building.

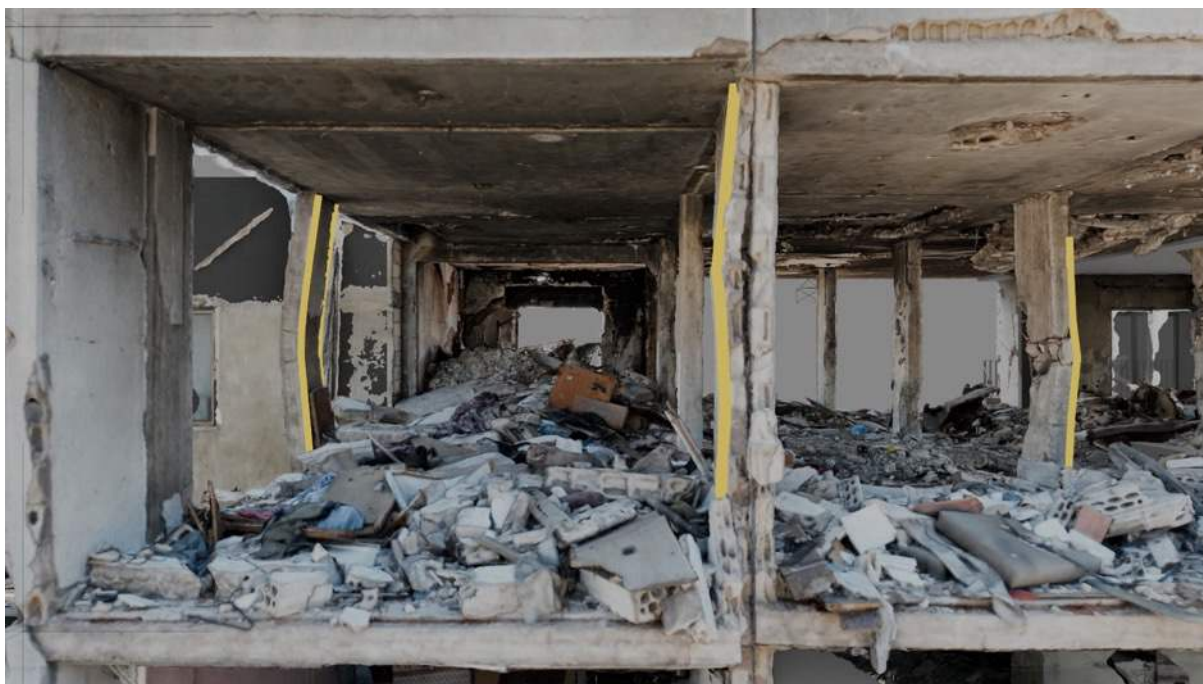
91 Deformation to structural columns was most notably observed around Bedroom 2, at the northeast corner of the flat (Figure 15).

Figure 15: View into Bedroom 2 of the Cherri flat from the north, with deformation marked.

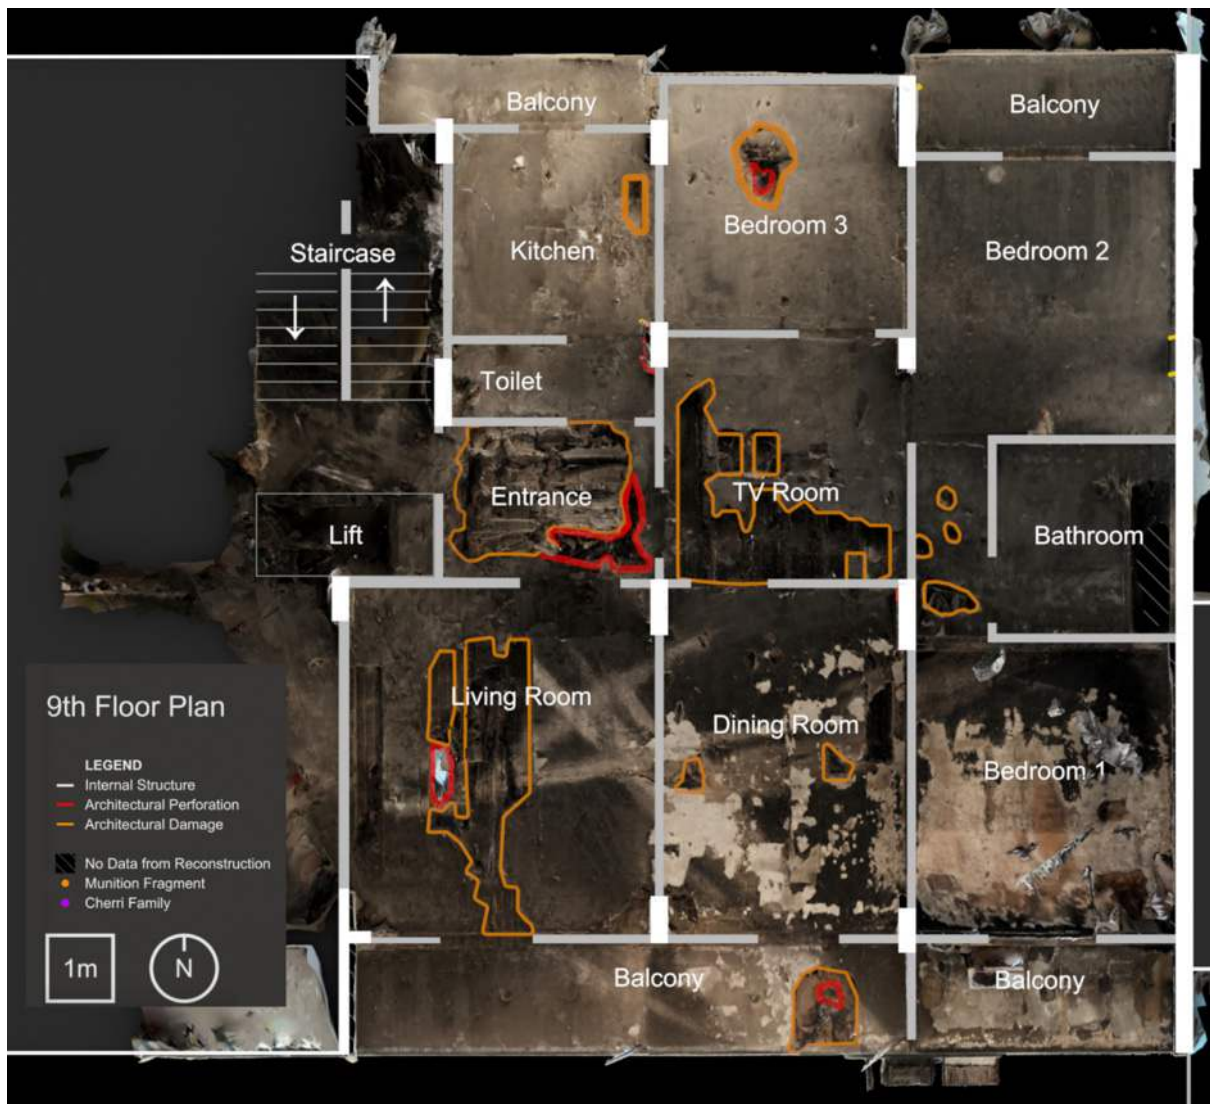
Figure 17: Reflected ceiling plan, the Cherri flat.

- 96 There is additional surface damage to the walls and ceilings of the flat (Figure 17):
- On the south balconies, there is damage to the dividing walls, and to the ceiling on the eastern side, surrounding a perforation.
 - On the living room ceiling, there is damage to the west side surrounding a perforation.
 - In Bedroom 3, there is damage to the ceiling surrounding a perforation on the north side, deformation and damage to the column on the northeast corner, and damage and deformation to the column on the southwest corner (Figure 15).
 - On the kitchen ceiling, there is damage to the northeast corner.
 - In the hallway between Bedrooms 1 and 2, there's damage to the ceiling.
 - In the TV room, there's damage to the column in the northeast corner.
 - In Bedroom 2, there's deformation and damage to the column on the east side.

- 97 Damage to the ceilings and floors in the Cherri flat is related in four main areas (Figure 16, Figure 17):
- In the entrance, the perforation in the floor corresponds with surface damage to the ceiling.
 - In the TV room, the perforation in the floor corresponds with surface damage to the ceiling.
 - In Bedroom 3, the perforation in the floor corresponds with surface damage to the ceiling.
 - In the southeast corner of the dining room, a perforation in the floor corresponds with a perforation in, and surface damage to, the east side of the ceiling of the adjacent balcony.

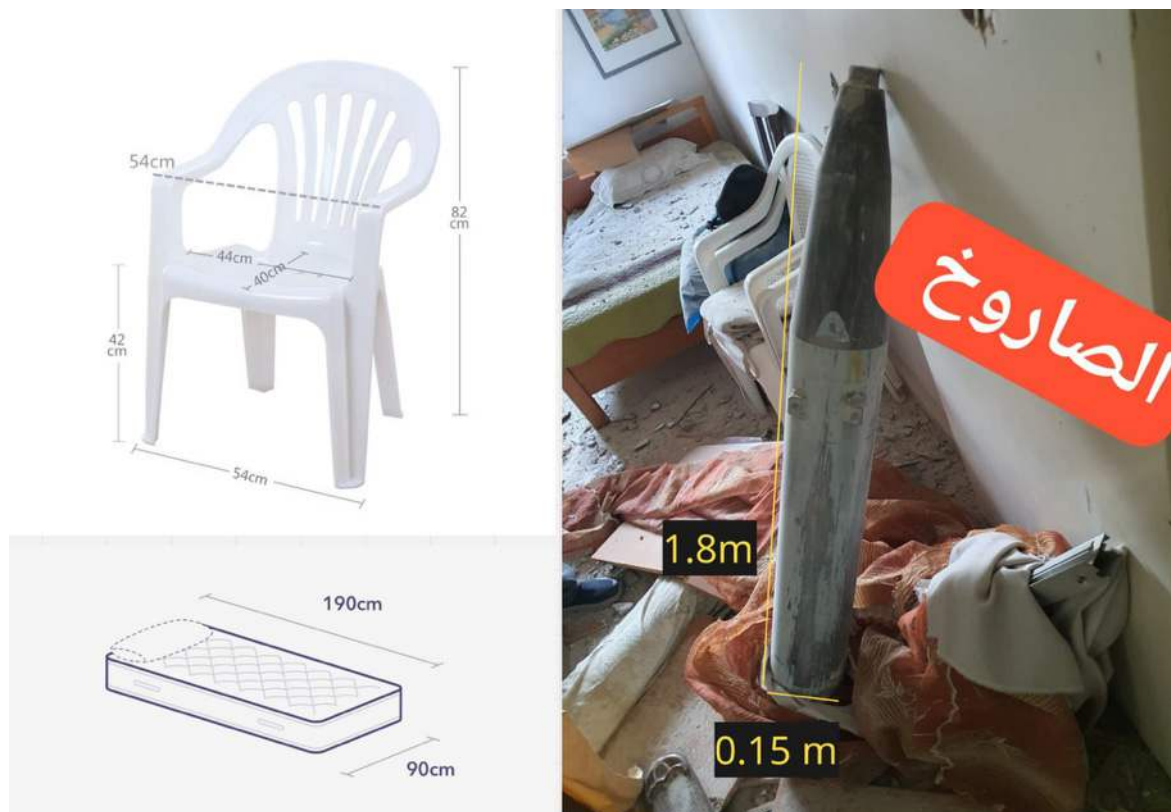
99 A photograph taken by a neighbour shortly after the attack shows an unexploded munition in a neighbouring building north-west of the Cherri building (Figure 18). In the photograph, the remnant is leaning against the wall, and its base is tangled in what appears to be a curtain. Light debris, including dust and broken glass, is visible across the room, on the floor, and on a bed in the background.

100 Witnesses describe the munition entering through the window on the evening of 26 November 2024, getting tangled in the curtain, and coming to rest in the position it is pictured in.

101 We were able to estimate the dimensions of the remnant by comparing its proportions with those of standard-size domestic furnishings in the photograph, namely the plastic chair and single bed (Figure 18). We estimate the remnant measures approximately 1.8m in length and 15cm in diameter.

Figure 18: Left: dimensions of domestic furnishings within the frame. Right: Munitions remnant found in the neighbouring building.

- 102 Nick Waters, a former army officer and open-source investigative expert with a focus on conflict, reviewed the image and identified it as the warhead of a GBU-39.

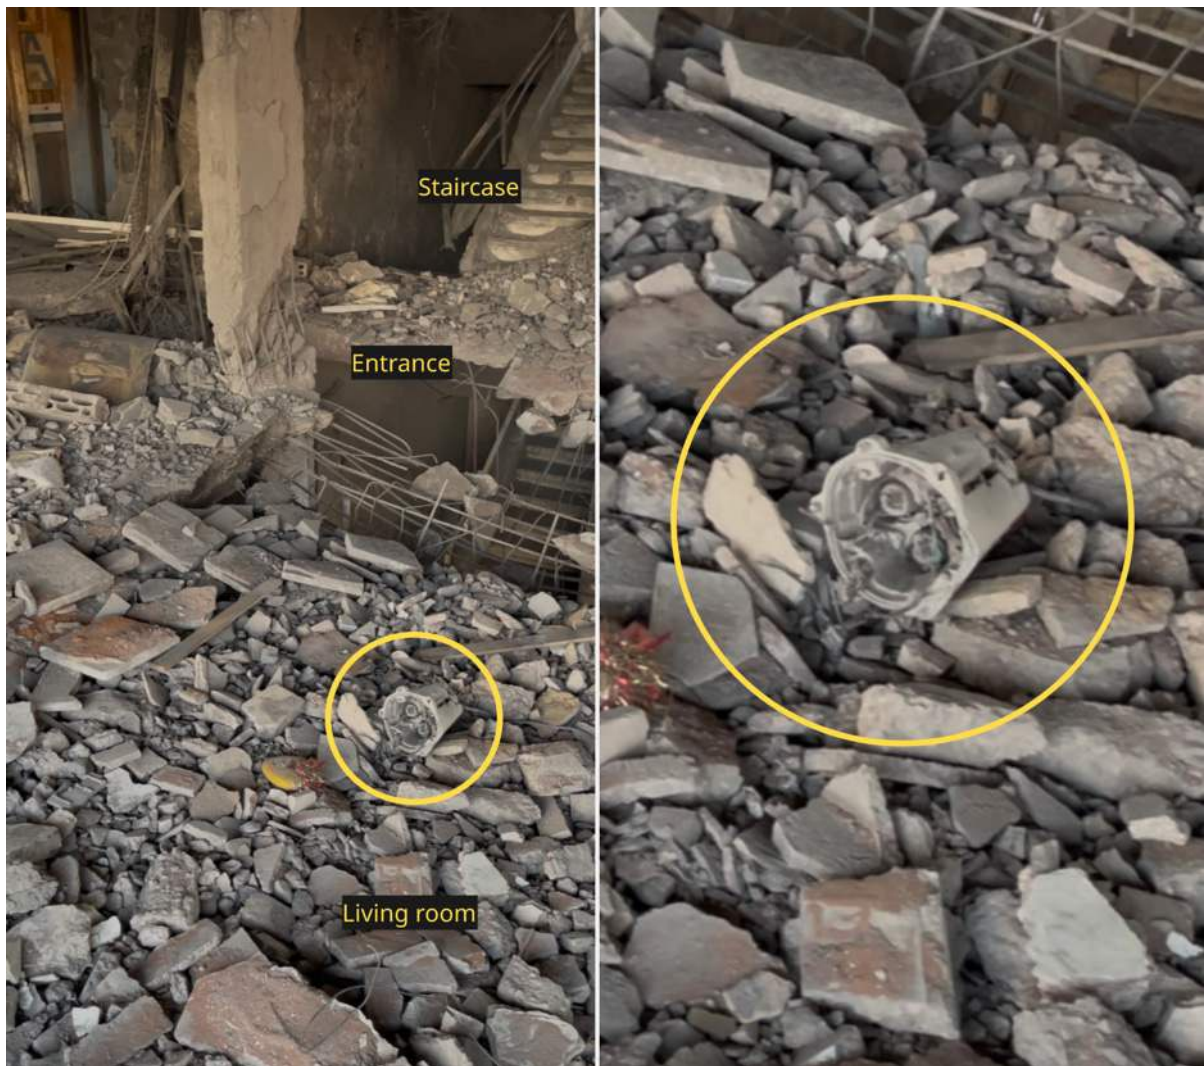
115 *'Tail actuation units very often survive impact. The fact that the tail actuation unit of the munition was found on the ninth floor of the Cherri building would suggest that it was attached to a GBU-39 that struck the Cherri building. It is highly unlikely that it detached from the munition that was found in the building on the opposite side of the street.'*

Figure 20: Annotated close-up of the tail actuation system identified in the Cherri flat.

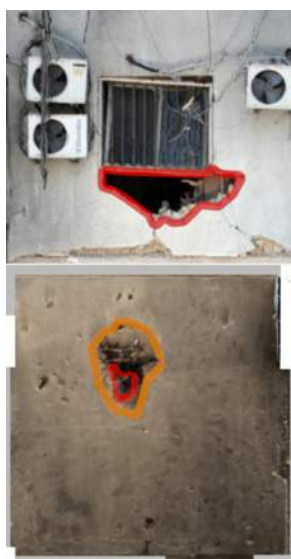
145 The model shows an alignment between perforations to the rear façade of floor ten and the ceiling of Bedroom 3 on floor nine (Figure 22).

Figure 22: Alignment between perforations (red) to the façade of floor ten, and the ceiling of Bedroom 3 on floor nine.

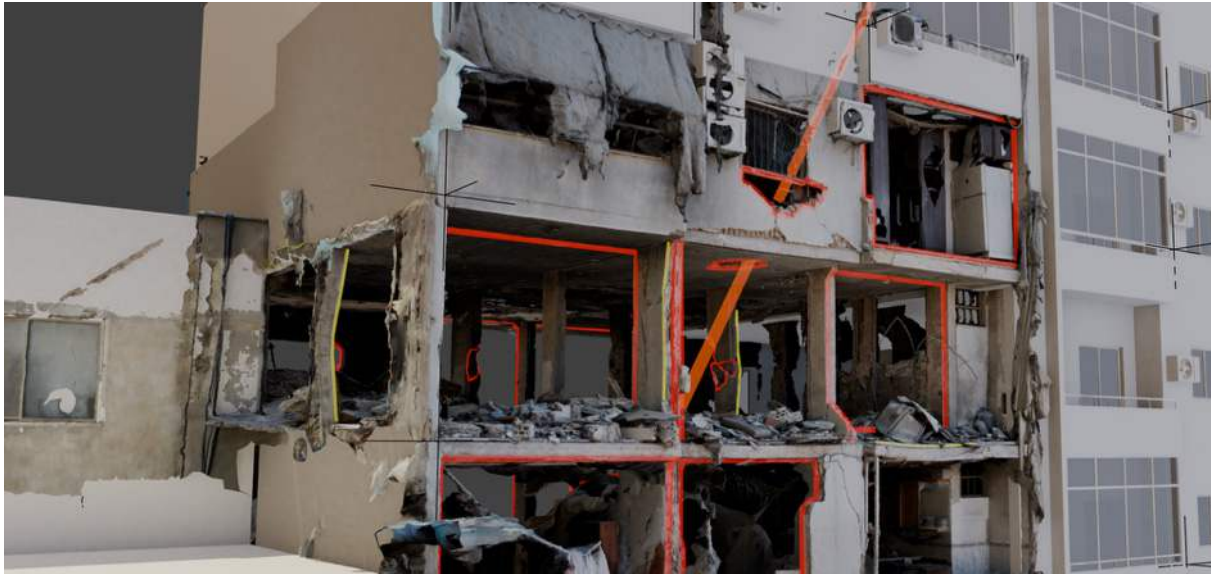
146 Both perforations have an approximate width of 0.7 metres. Therefore, it is possible that a munition has entered through the exterior rear wall of floor ten, passed through the floor, and entered the ceiling of Bedroom 3 on floor nine (Figure 23).

Figure 23: North-east façade view of the alignment between perforations on floors ten and nine, as indicated by the red line.

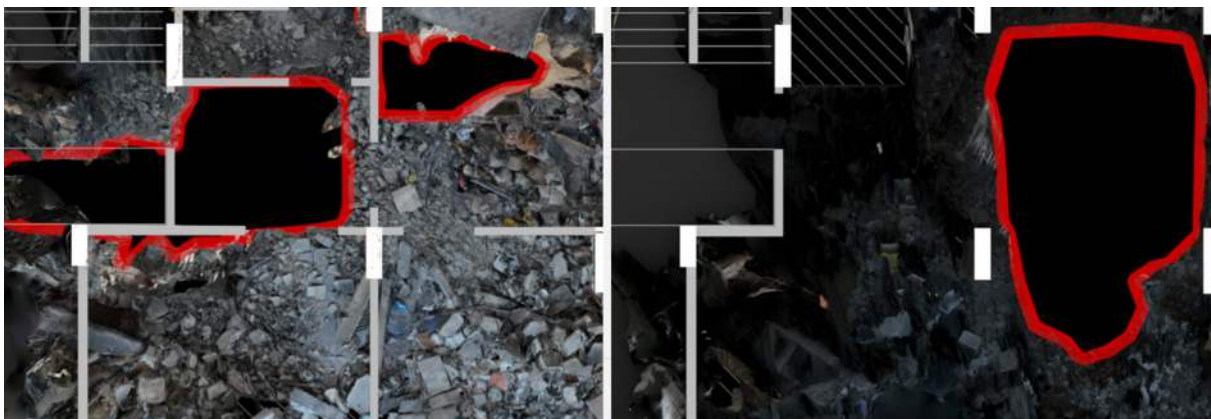
148 Based on the size of the perforations, there is a possibility that a munition detonated in the entrance of floor nine, and/or the TV room of floor eight.

Figure 24: Alignment between perforations to the floor of the TV room and entrance on floor nine (left), and floor eight (right).

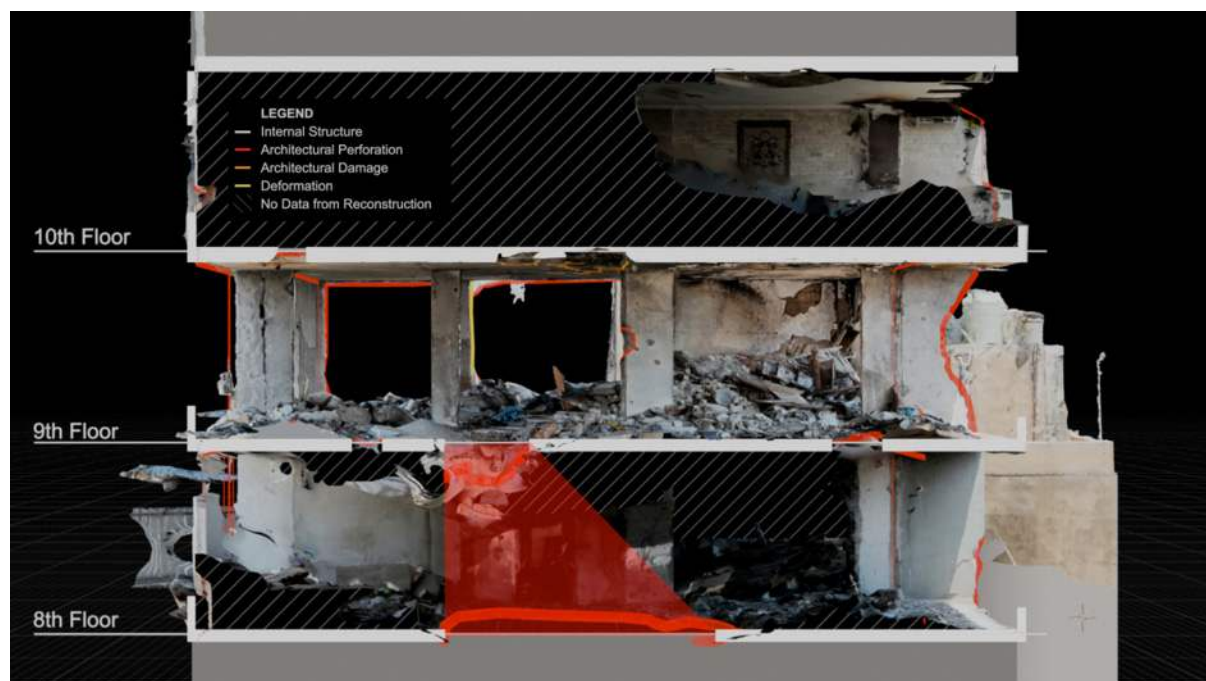
Alternatively, it could have passed through floor nine before detonating on floor eight.

Figure 25: Alignment between perforations in the TV room on floor eight and nine.

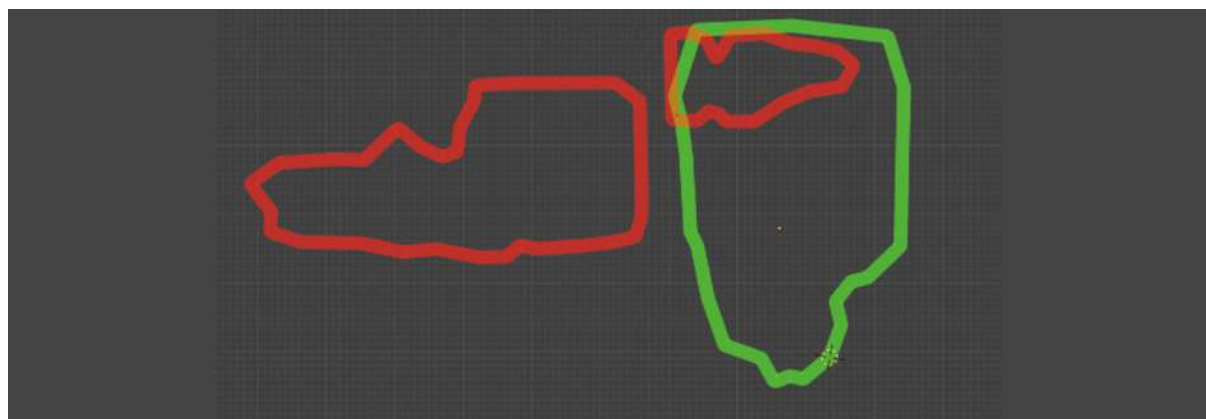
Figure 26: Comparison of perforations in the TV room and entrance of floor eight (green) and floor nine (red).

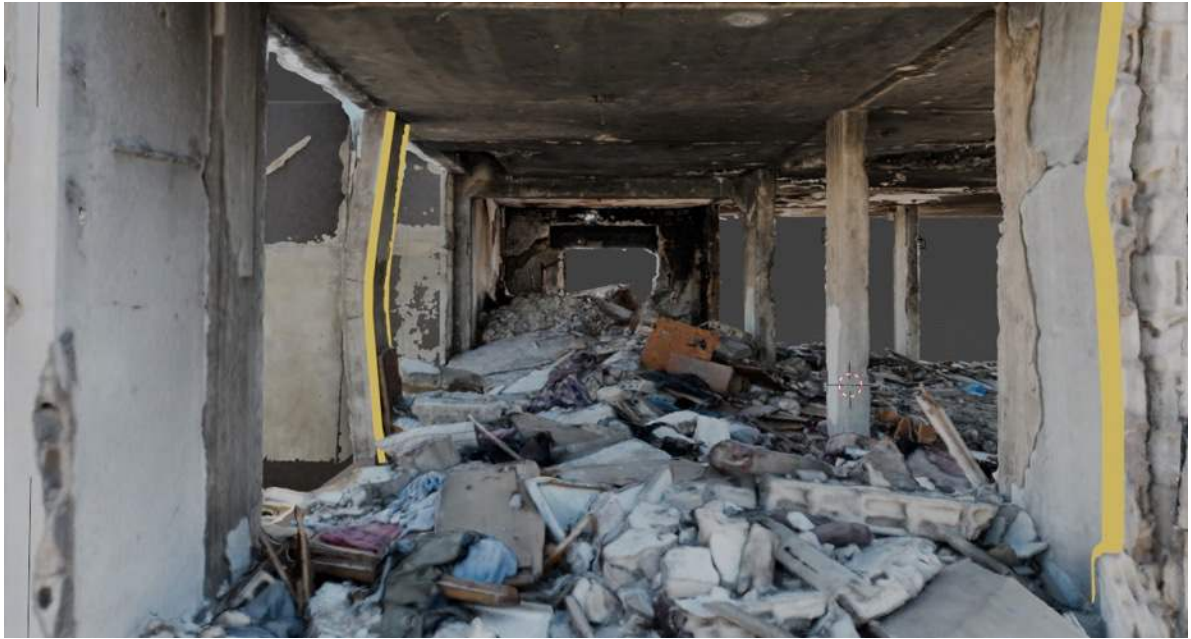
149 As discussed in H.2.1, the weapons expert assessed it to be highly unlikely the warhead found in the neighbouring building sustained the level of damage visible in the photograph solely by passing through a window: the munition must have passed through hard surfaces, such as wall(s) or floor(s).

150 Witness testimonies describe the munition passing through the window of the sixth floor. Given the weapon expert's analysis and the absence of visible damage to other surrounding buildings, if the testimony is accurate, the munition likely passed through the Cherrri building before landing undetonated in the neighbouring building.

Figure 27: Close up of Bedroom 3 in the northeastern corner of the Cherri flat, with deformations to structural columns marked in yellow.

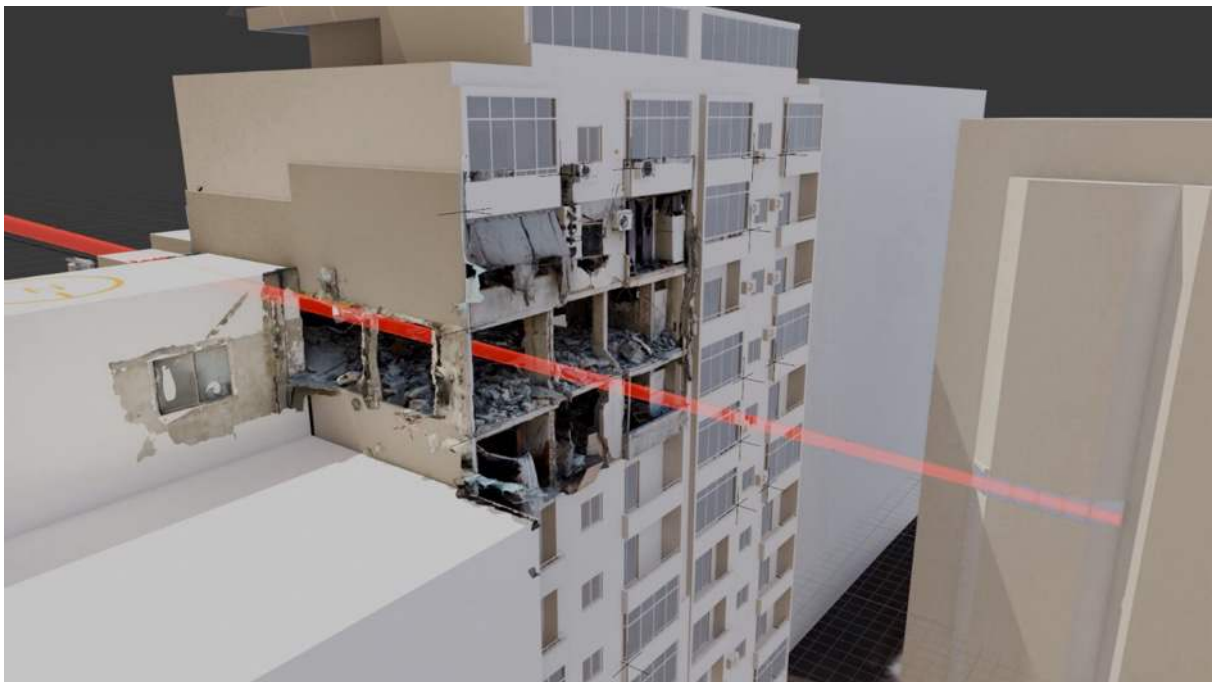
151 A trajectory for this possible scenario can be approximately mapped. In the northeastern corner of the Cherri flat, in Bedroom 2, we see deformation to structural columns but no visible damage or perforations on the ceiling or floor. This suggests the room was not affected by a detonation. It could also suggest the passage of a projectile, which exerts substantial force. The munition could have passed through this area before landing undetonated on the sixth floor of the neighbouring building (Figure 28).

Figure 28: Rear view of the Cherri flat, showing possible trajectory for the GBU-39 warhead.
